RESULTS OF 2018 MONITORING OF THE TALGAR WORLD HERITAGE SITE

Results of monitoring of the Talgar world heritage site: March – December 2018.

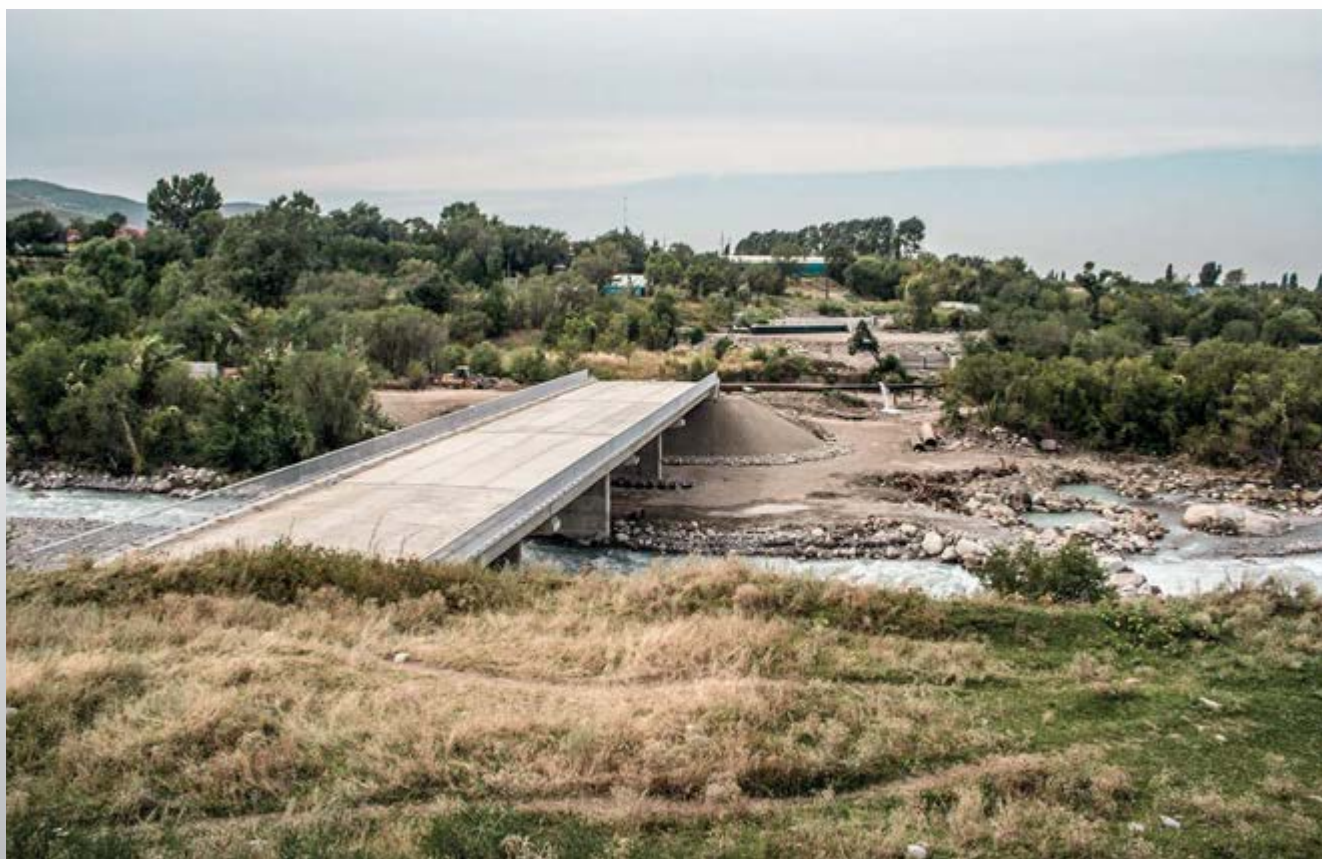
Construction of the bridge. August 9, 2015.

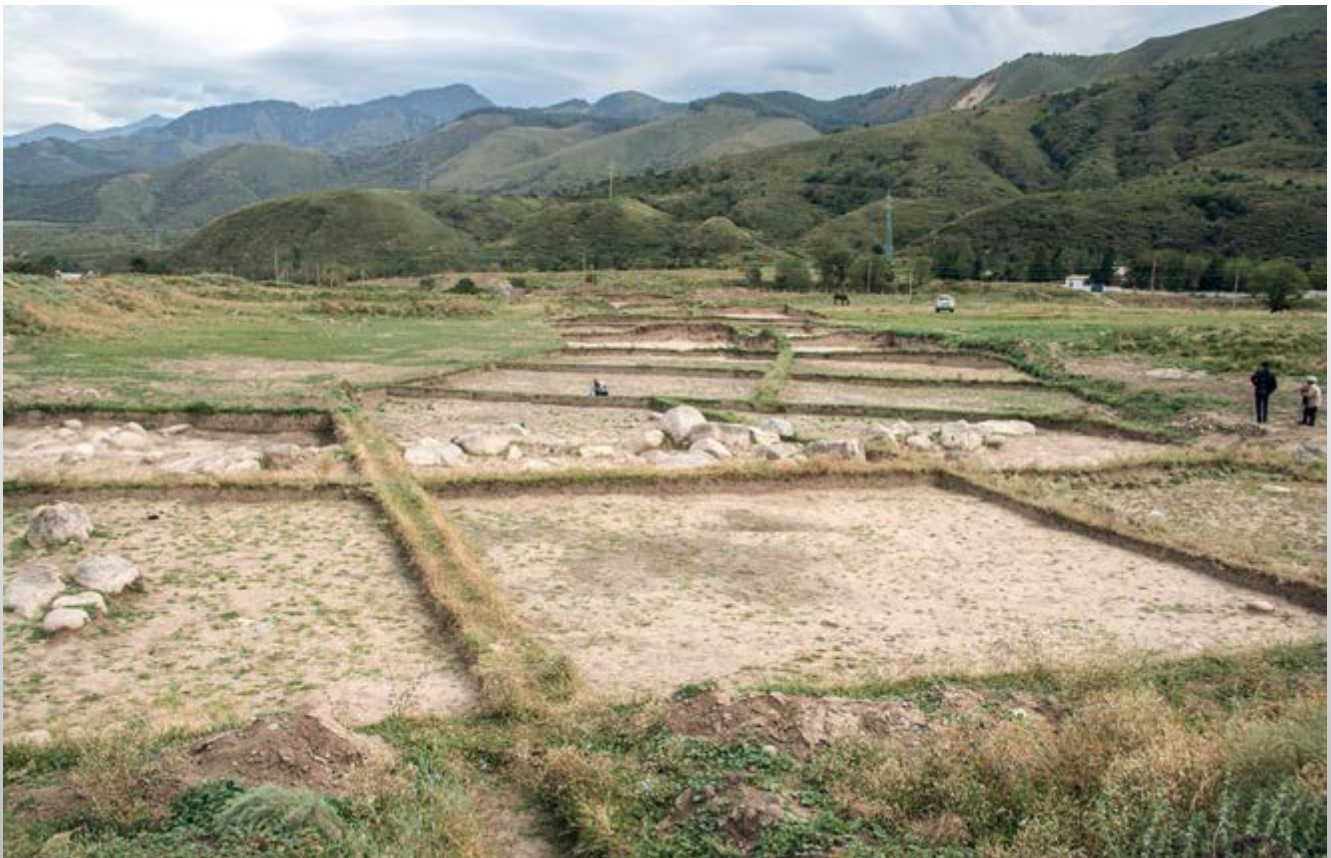
Excavations for the proposed road passage. September 2, 2016.

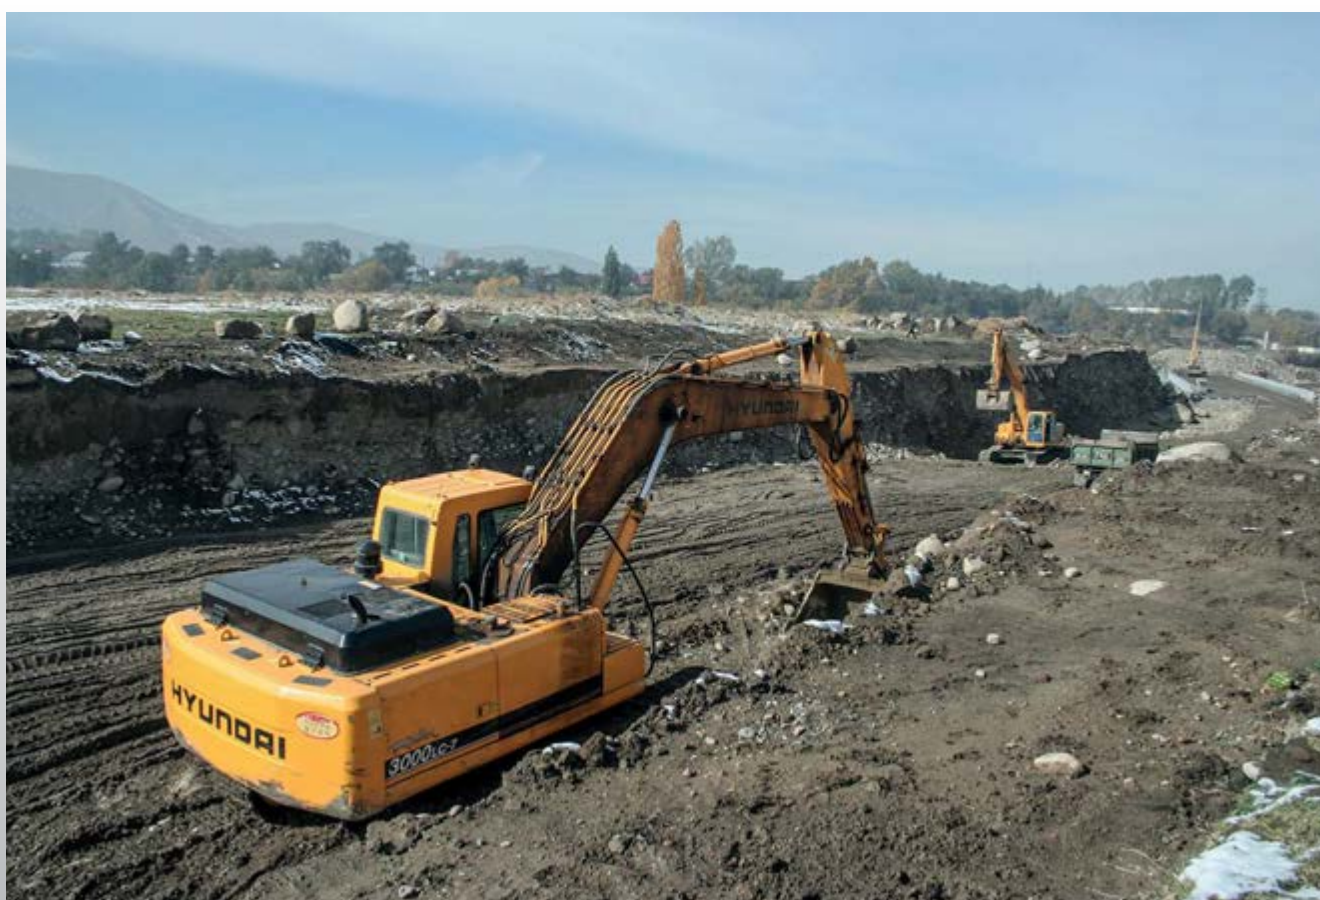
Excavation for the road bed. October 15, 2016.

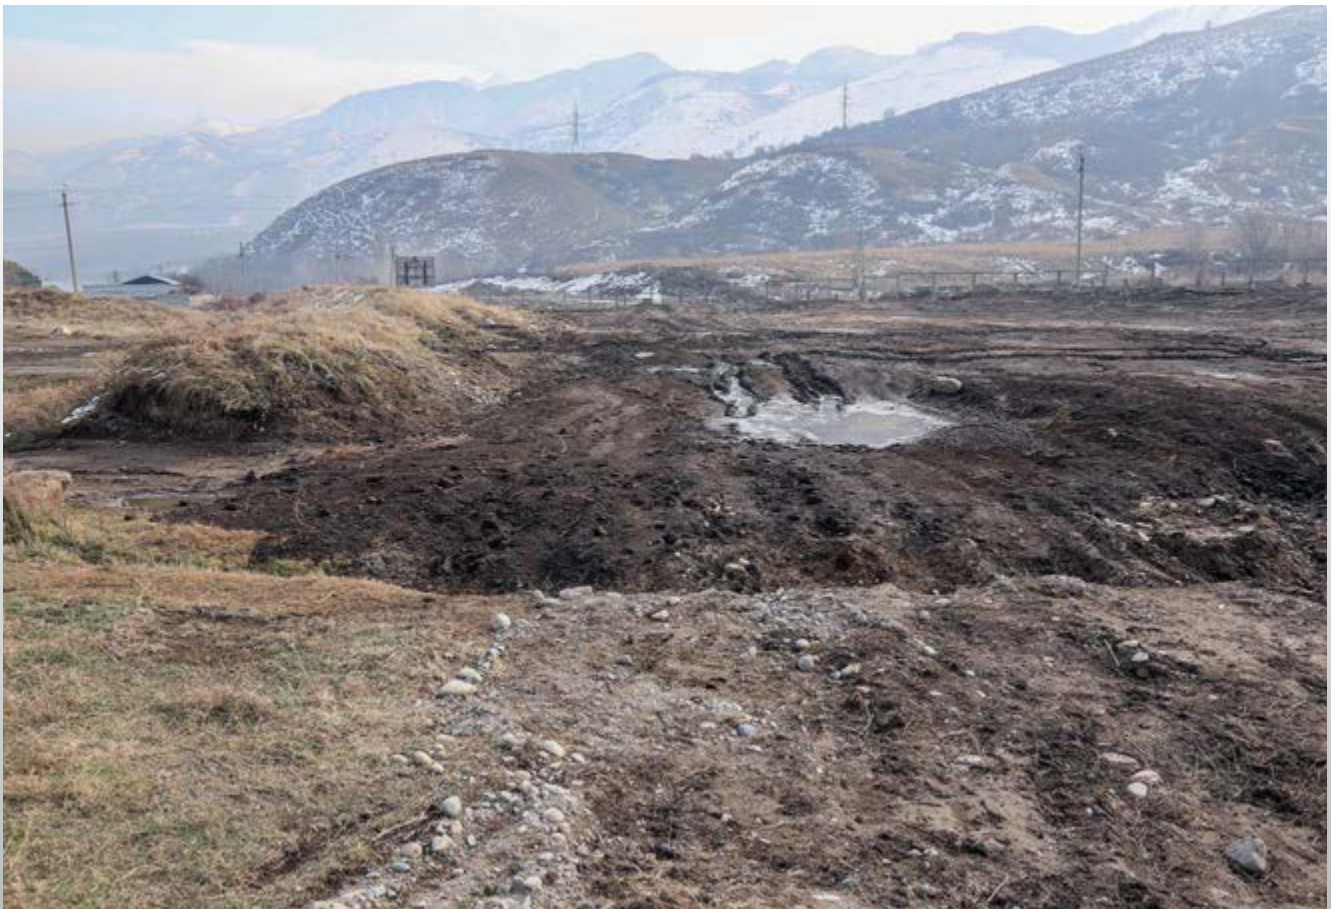
The area, which was excavated for the road passage and later filled back with dirt, continues to settle. In spring, huge puddles formed in the specified area. In fall,

local residents and, probably, the road construction workers set a pass to the bridge through this area of the hillfort.

Current condition of the area where the ground was excavated for the road bed. December 16, 2018.

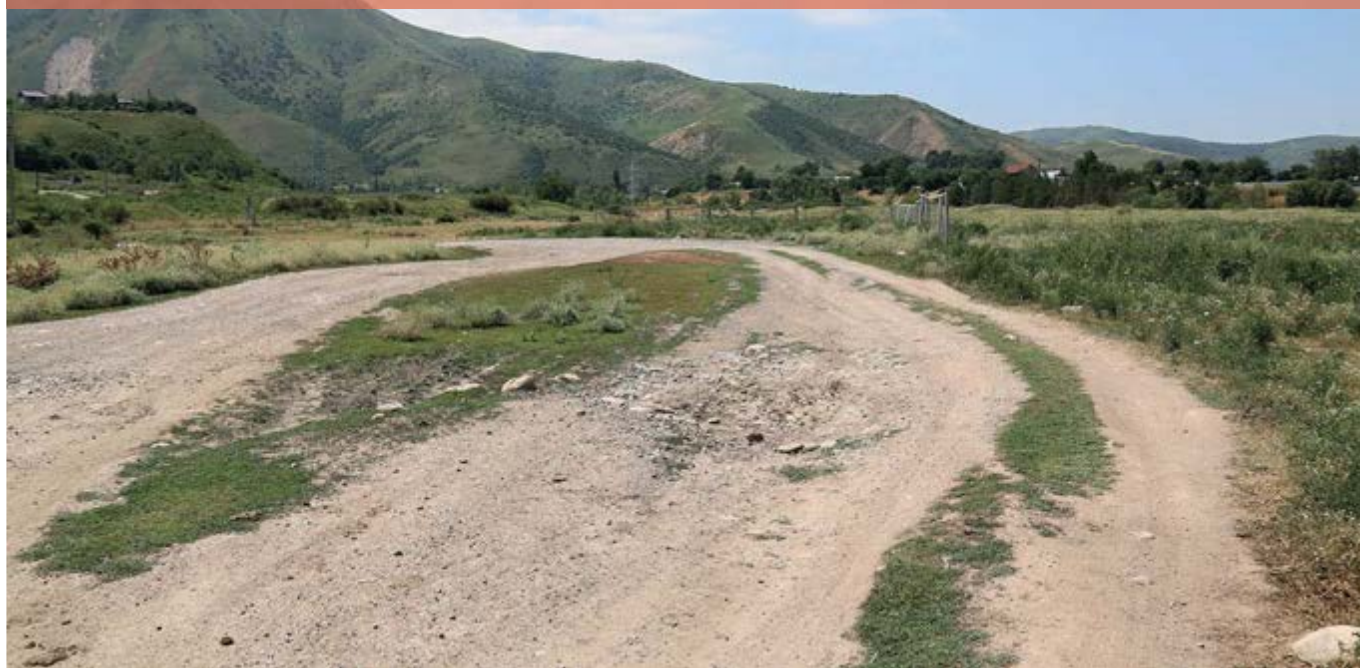
Picture 1. Condition of the road and fencing around the site.
July 6, 2018.

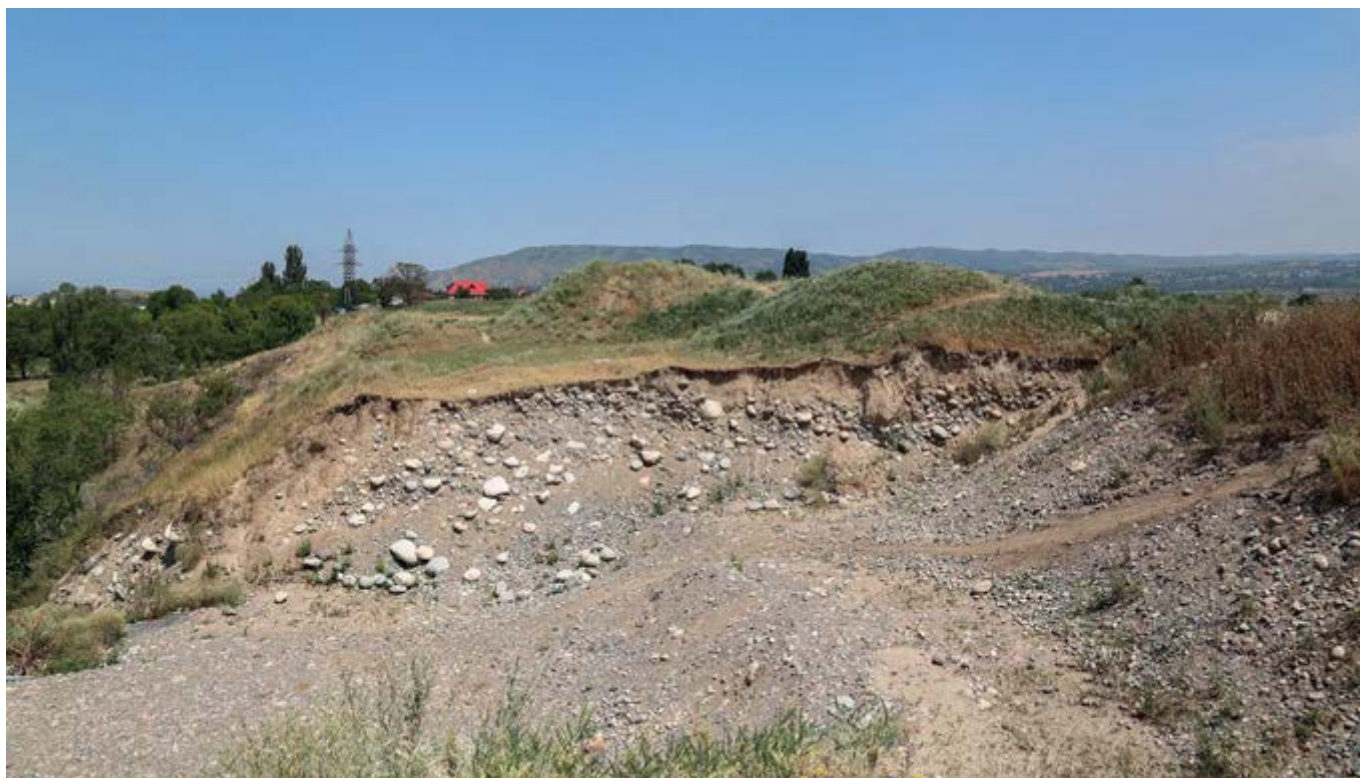
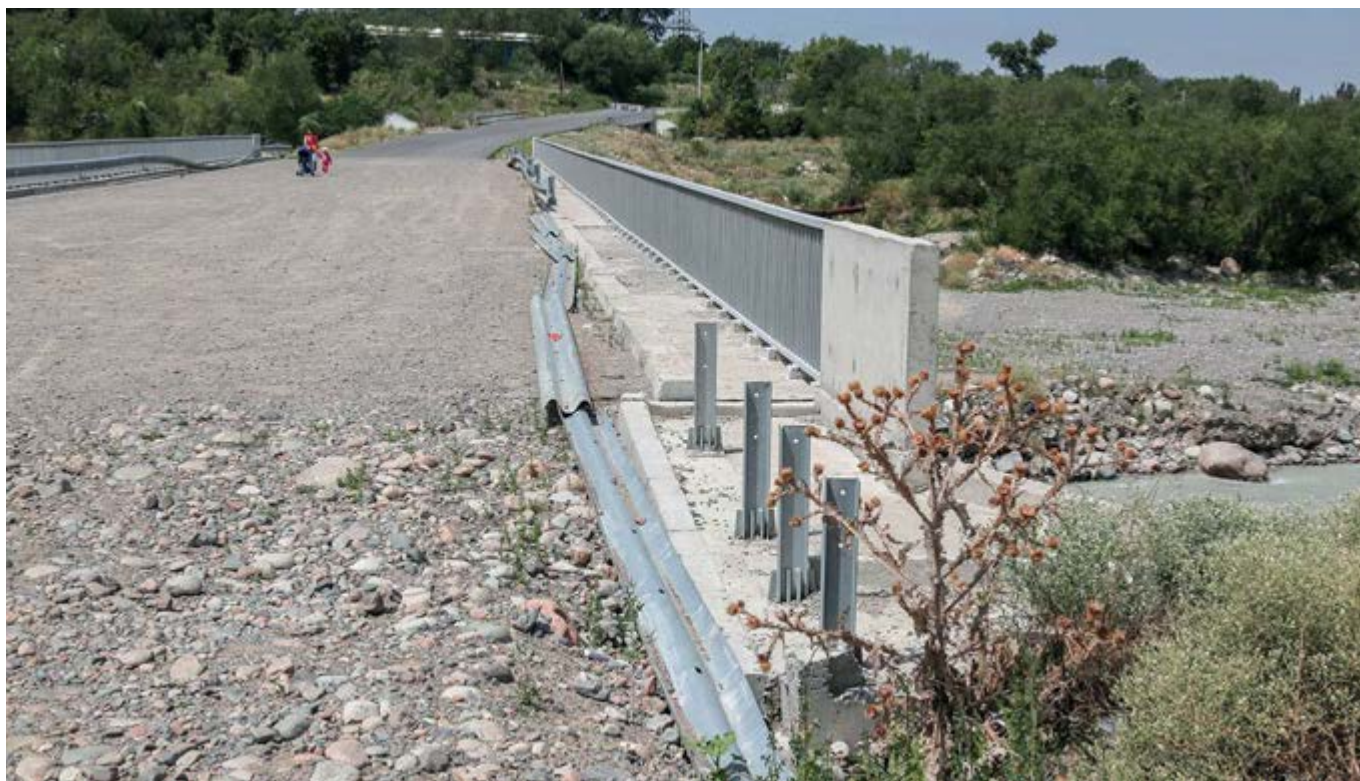
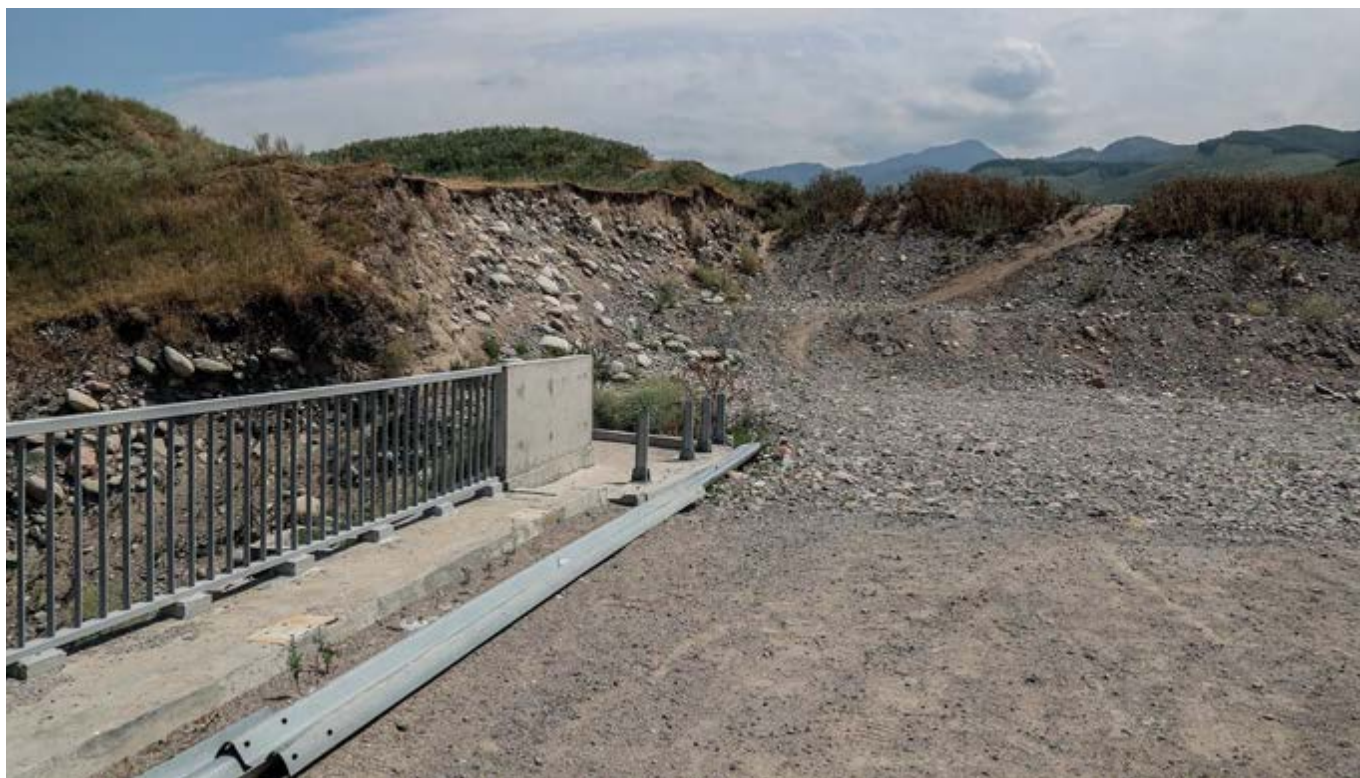
Since the bridge over the Talgar River is not dismantled, drivers of off-road vehicles and heavy construction machinery equipped a ramp to the bridge from the hillfort, passing through its unfenced part. To the east and southeast of the hillfort, the construction workers repaired the road raising its level. This can lead to negative consequences for the territory of the monument.

*Picture 3. Downhill path to the bridge from the hillfort.
July 26, 2018.*

*Picture 4. View of the bridge from the hillfort.
July 26, 2018.*

*Picture 5. The bridge and the downhill path to it from the hillfort.
July 26, 2018.*

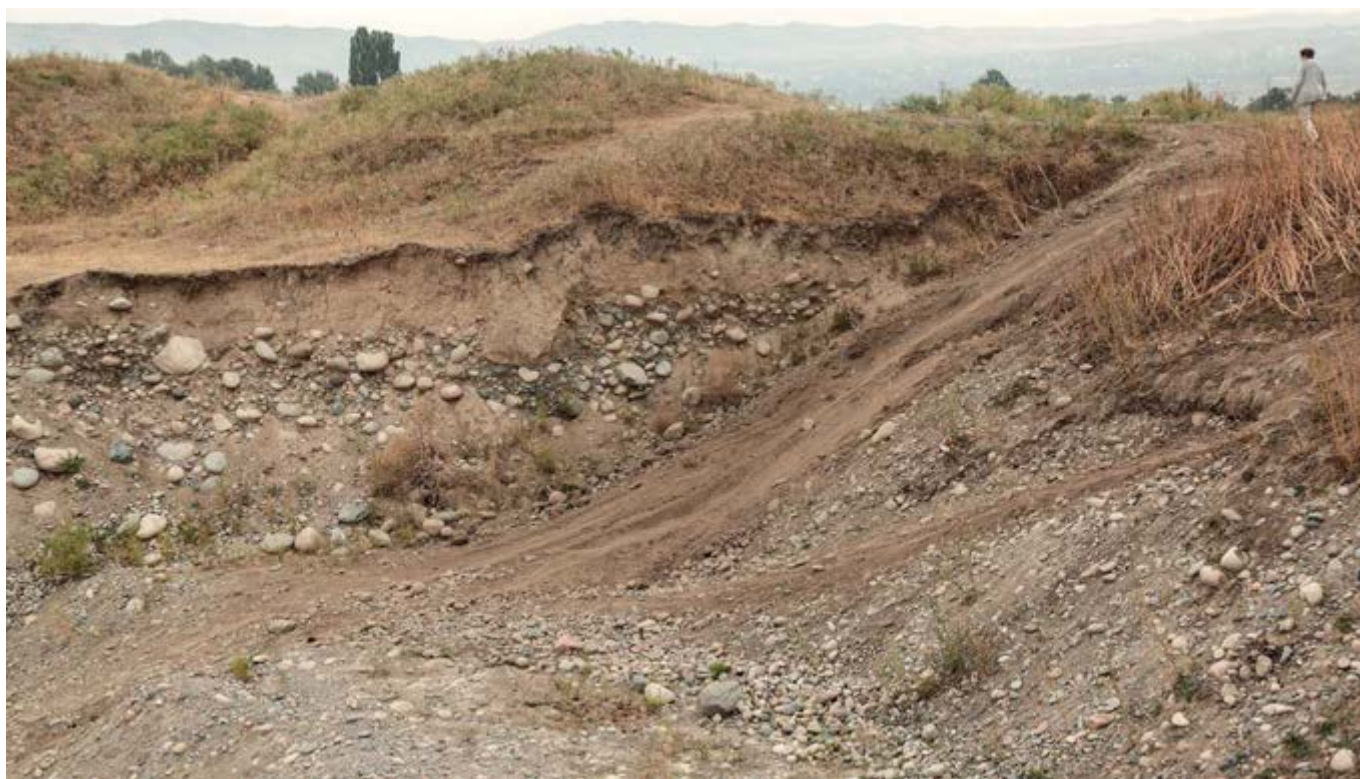
*Picture 6. Vehicles started to drive onto the bridge.
September 10, 2018.*

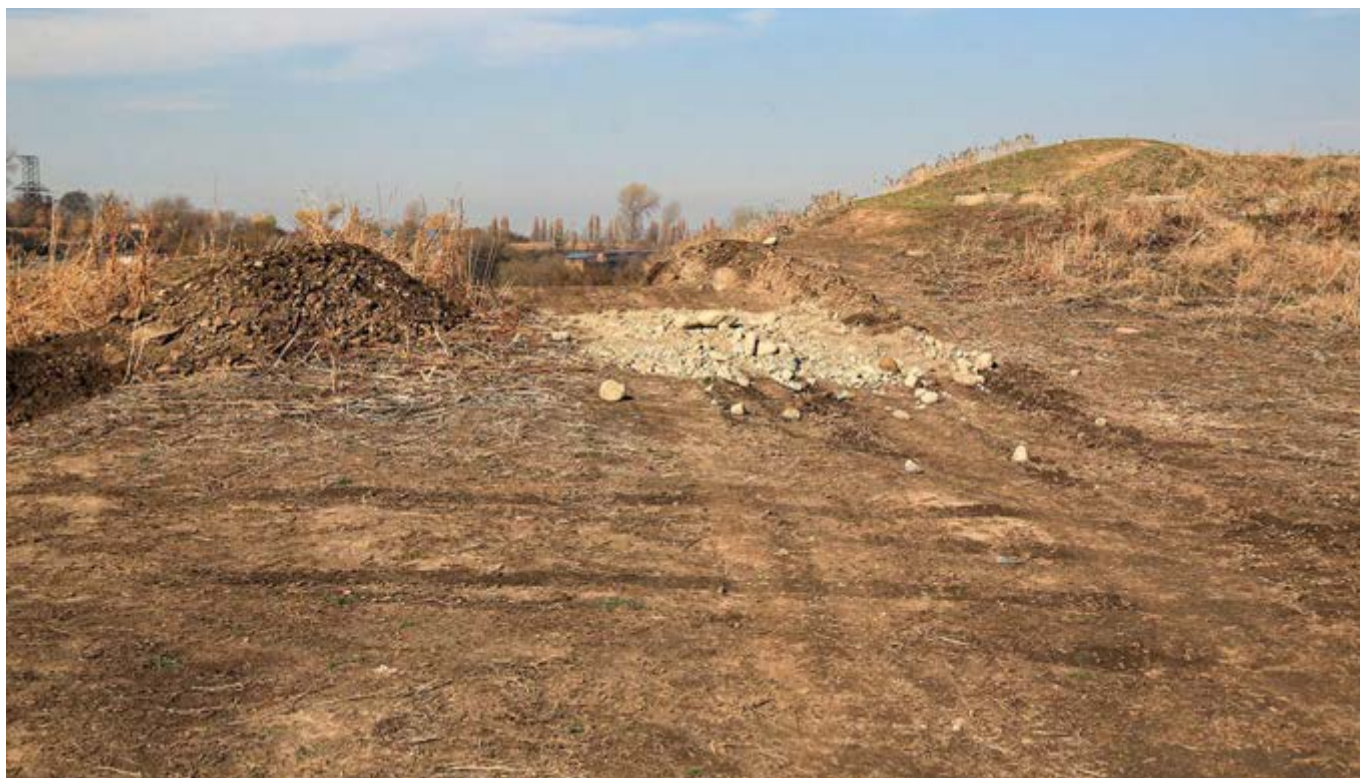
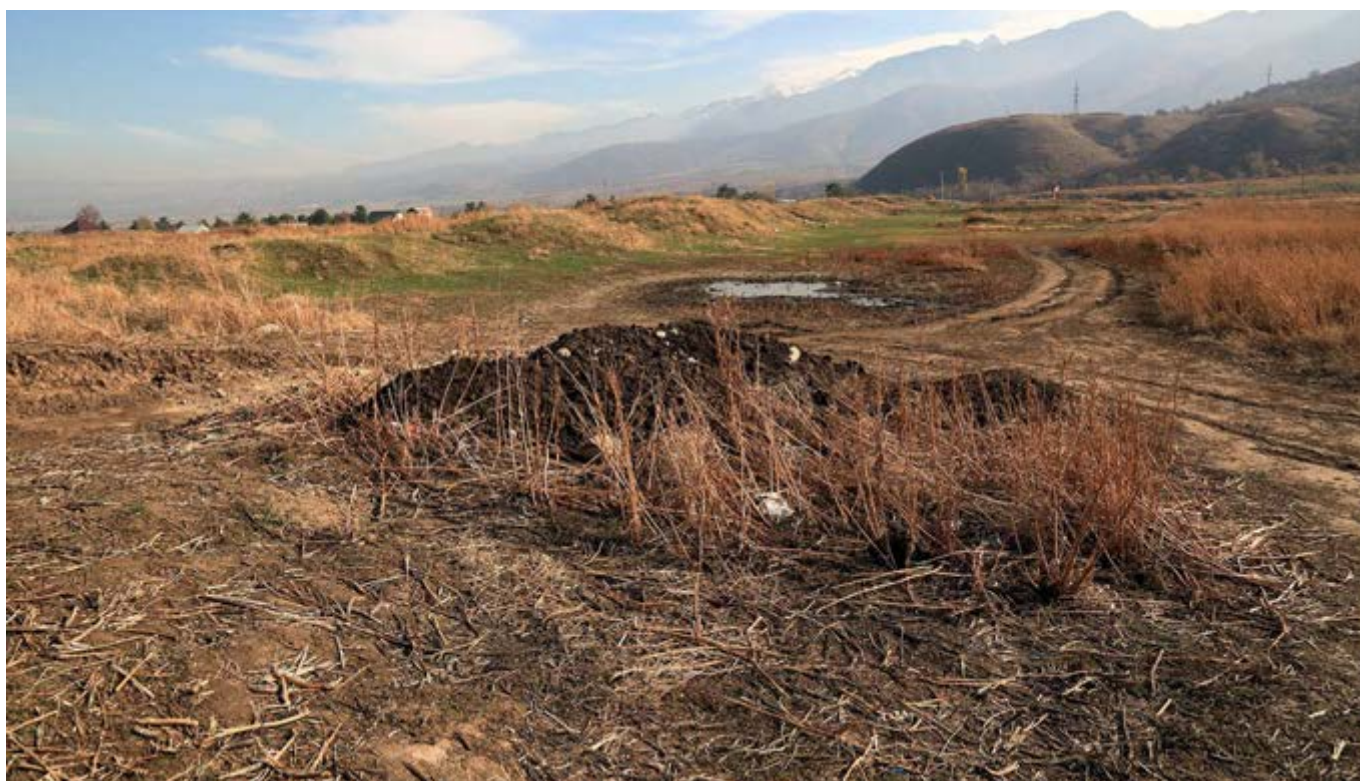
*Picture 7. **Excavated and refilled area in front of the ramp to the bridge.***
October 30, 2018.

*Picture 8. **Excavated and refilled area in front of the ramp to the bridge.***
October 30, 2018.

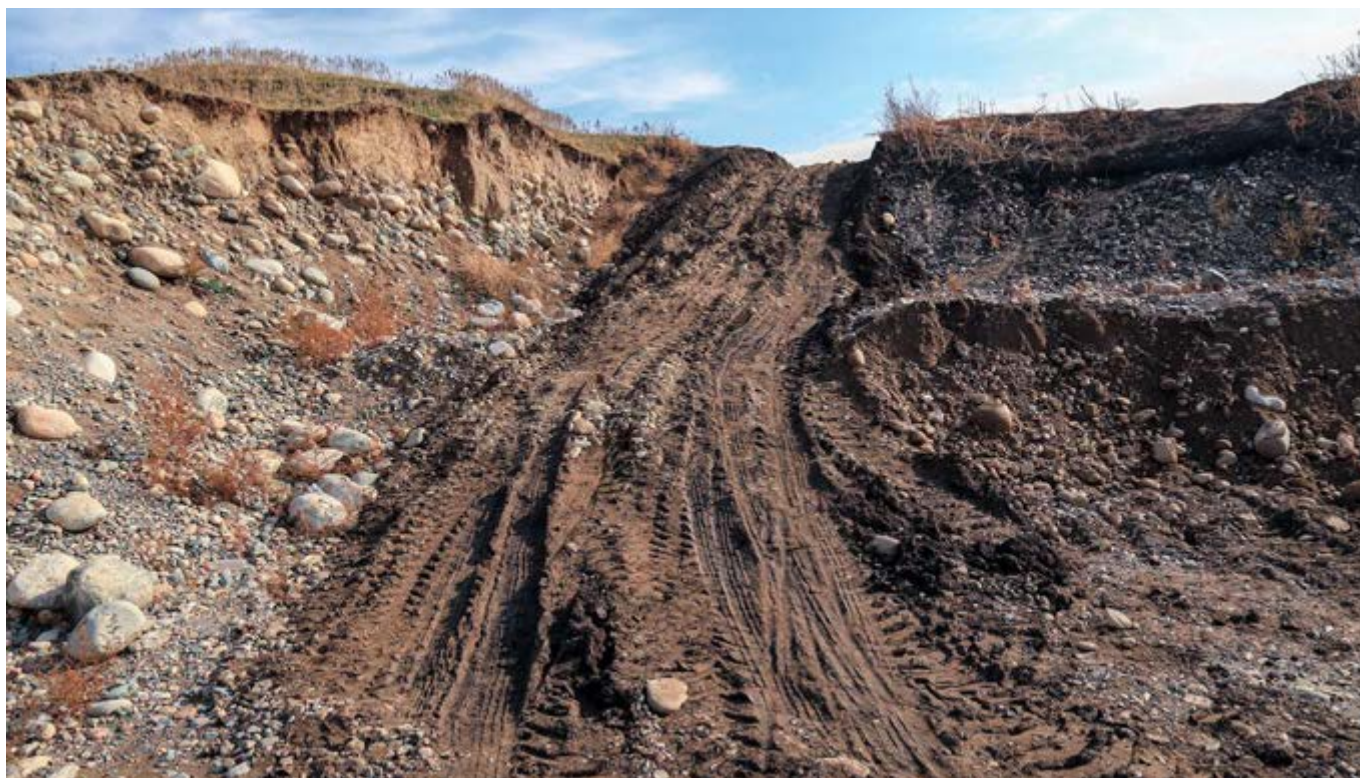
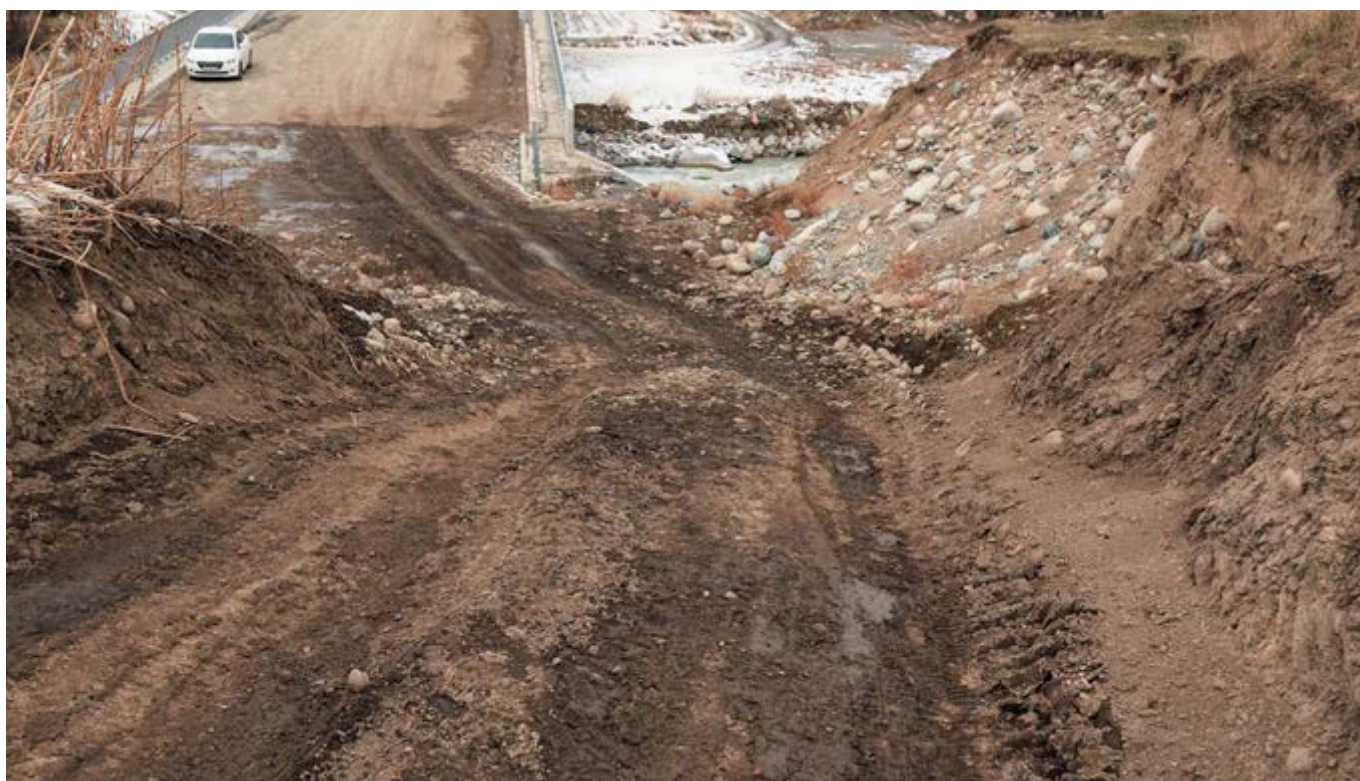
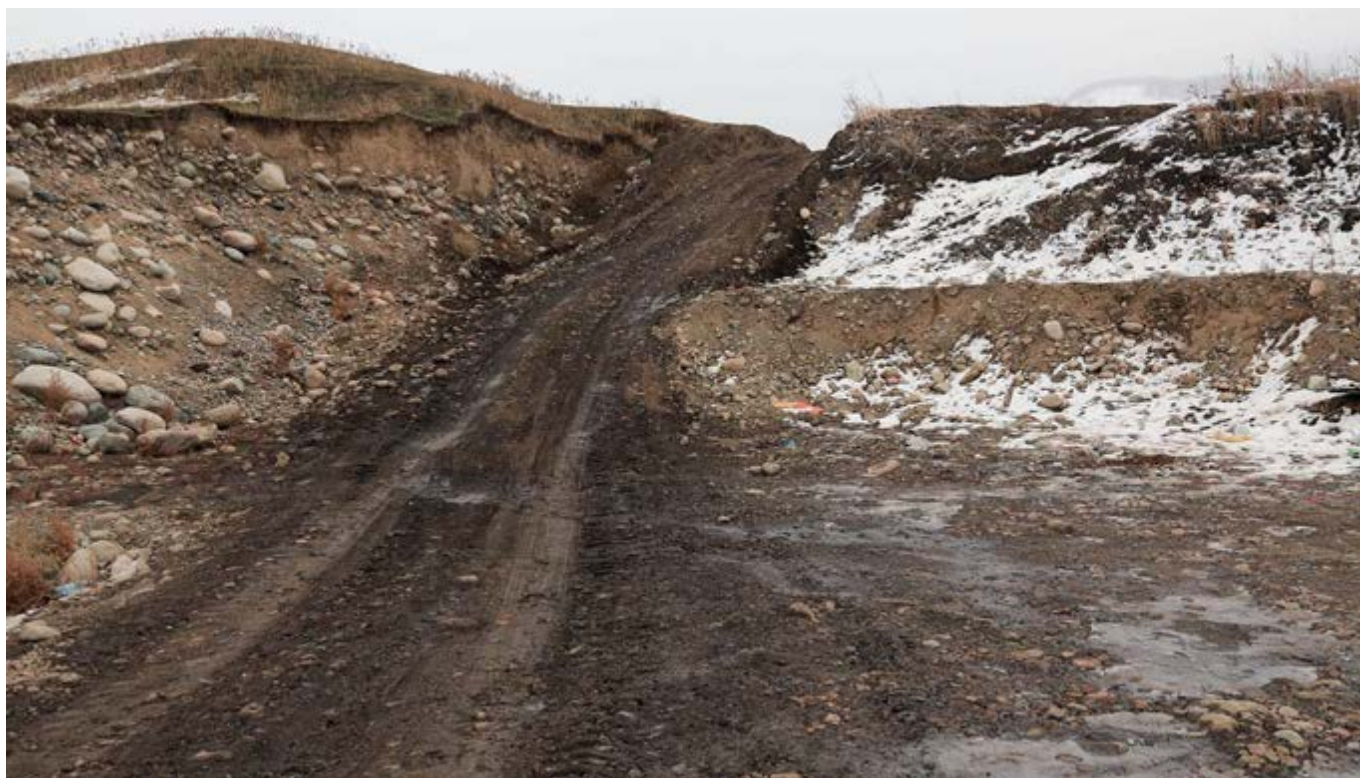
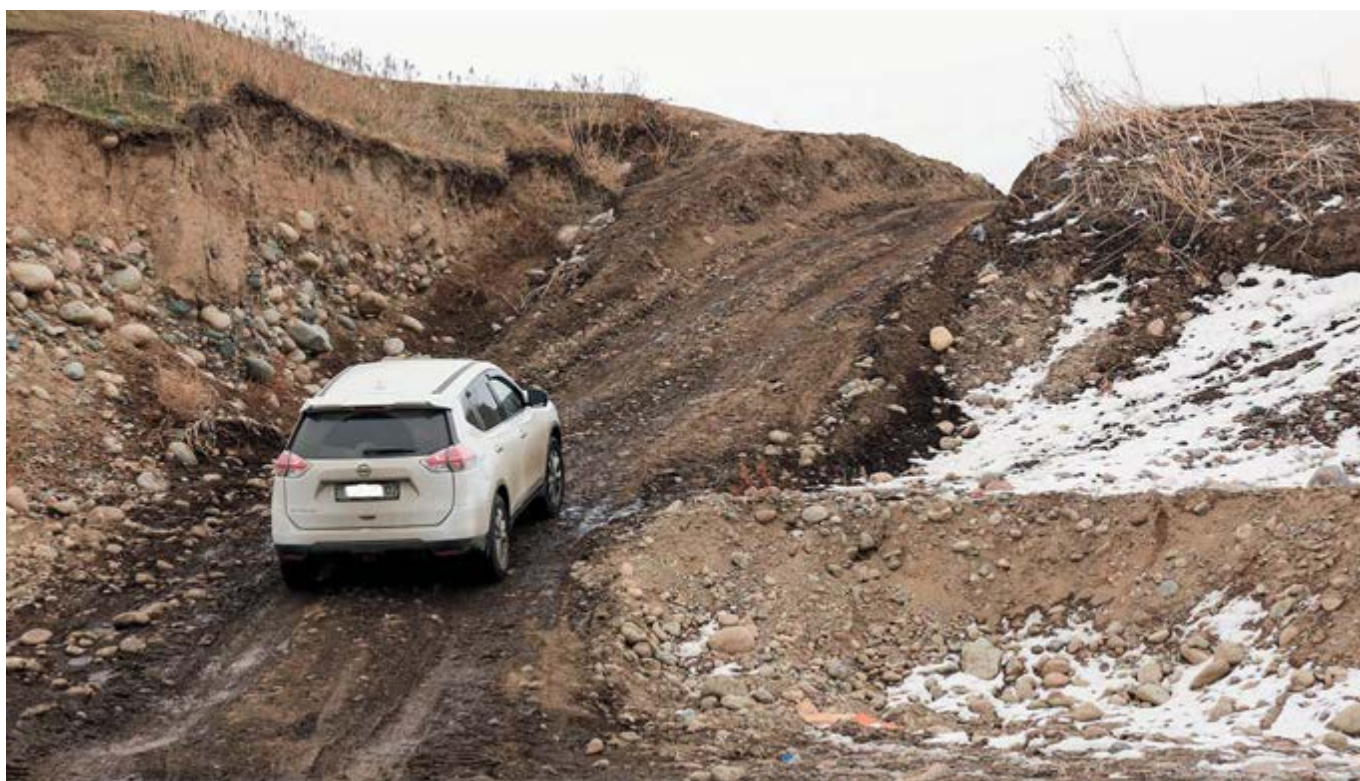
*Picture 9. **Passage from the bridge onto the territory of the hillfort.**
October 30, 2018.*

*Picture 10. **Passage from the bridge onto the territory of the hillfort.**
December 16, 2018.*

*Picture 11. **Passage from the bridge onto the territory of the hillfort.**
December 16, 2018.*

*Picture 12. **Passage from the bridge onto the territory of the hillfort.**
December 16, 2018.*

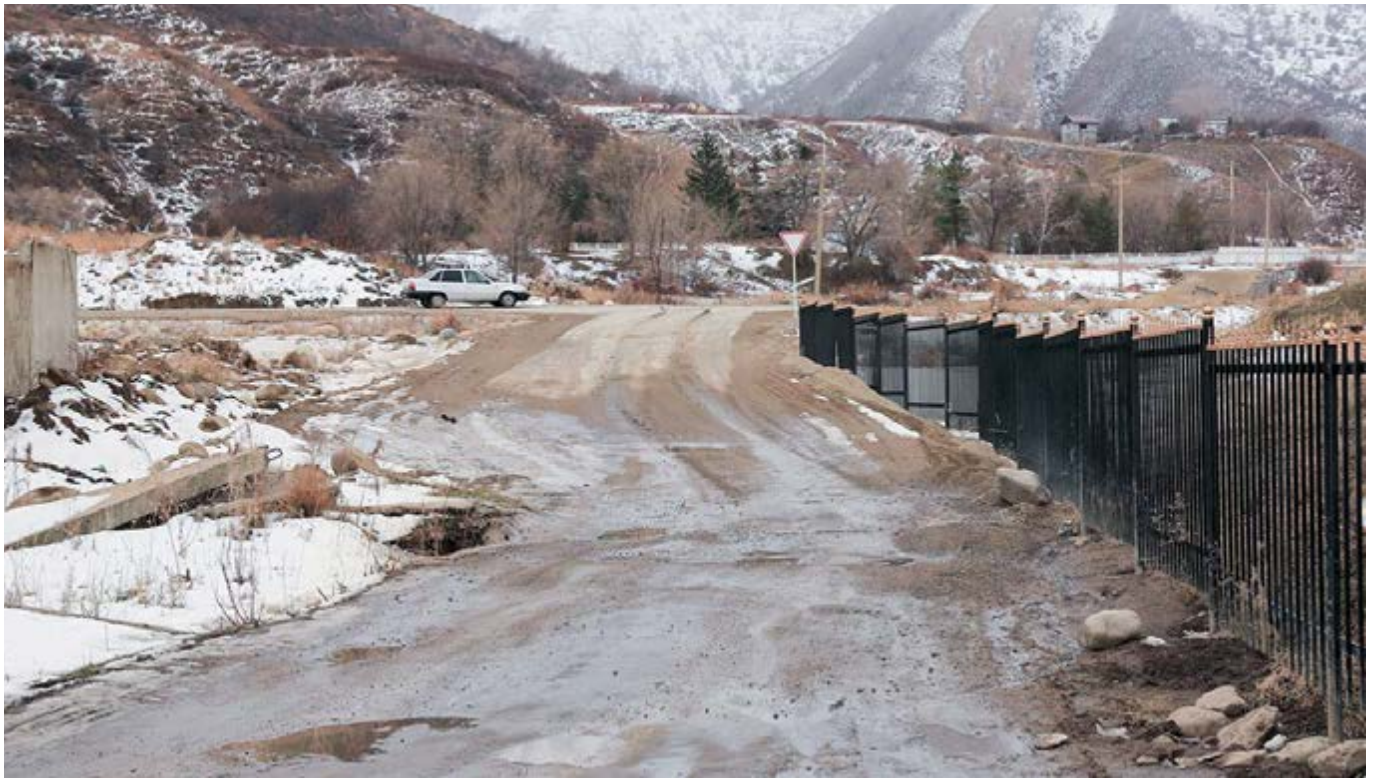
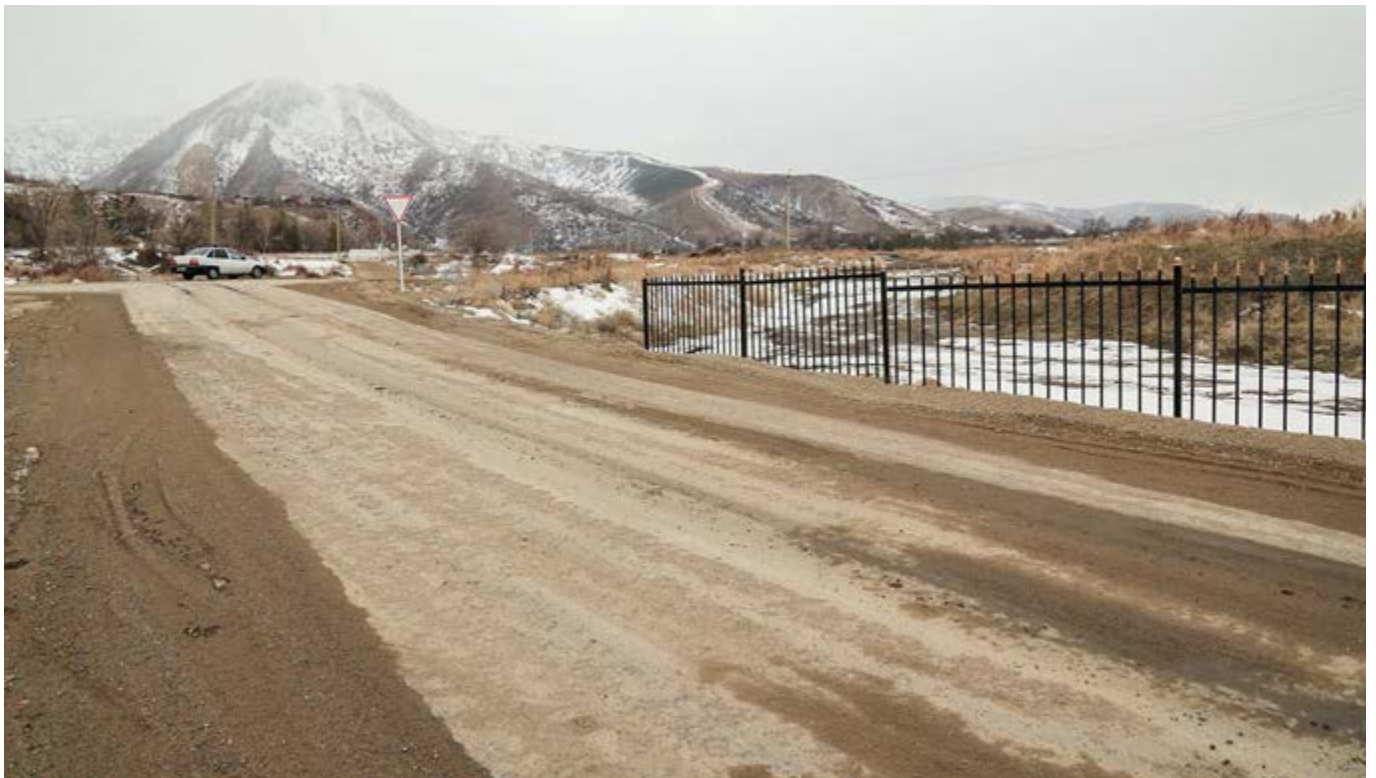
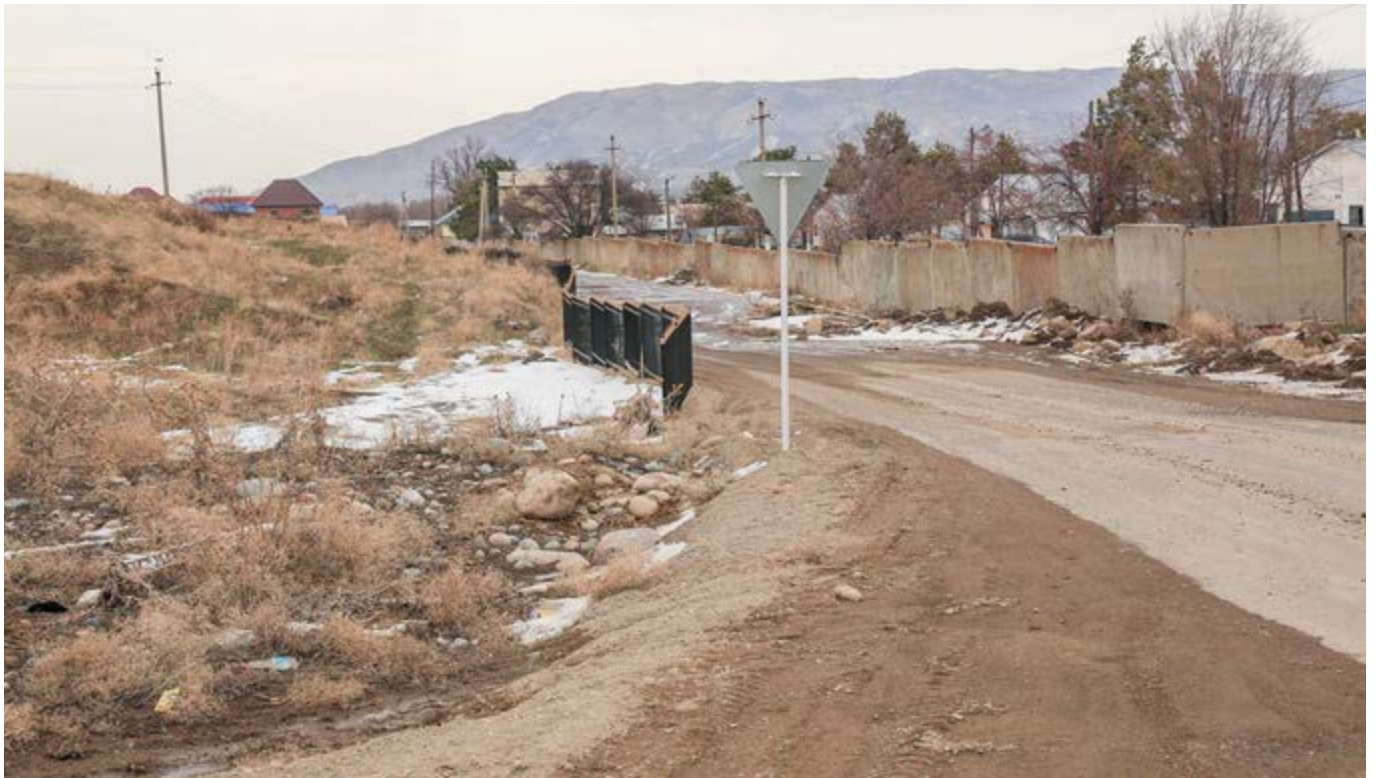
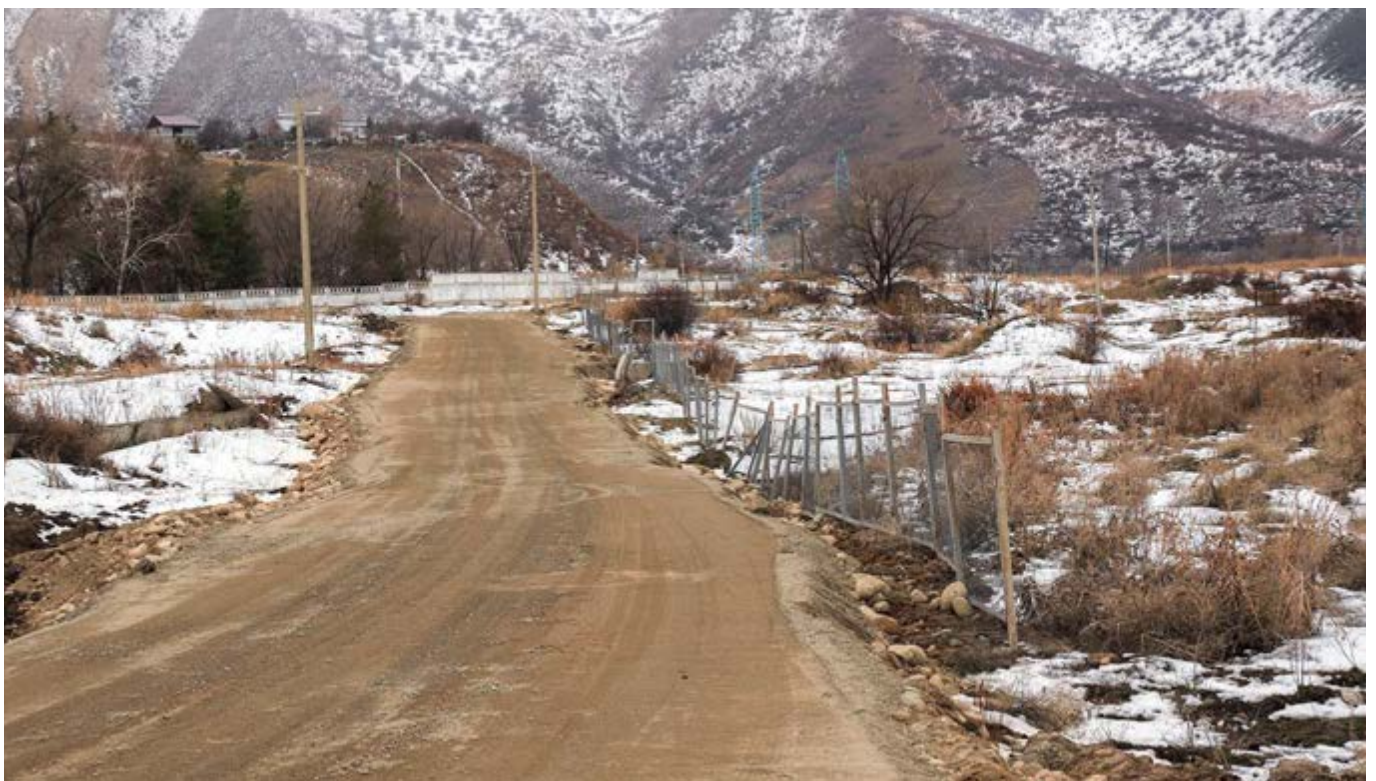
Picture 13. Construction workers repaired and raised the road from the east and southeast side of the hillfort.

Picture 14. Construction workers repaired and raised the road from the east and southeast side of the hillfort.

Picture 15. Construction workers repaired and raised the road from the east and southeast side of the hillfort.

Picture 16. Construction workers repaired and raised the road from the east and southeast side of the hillfort.

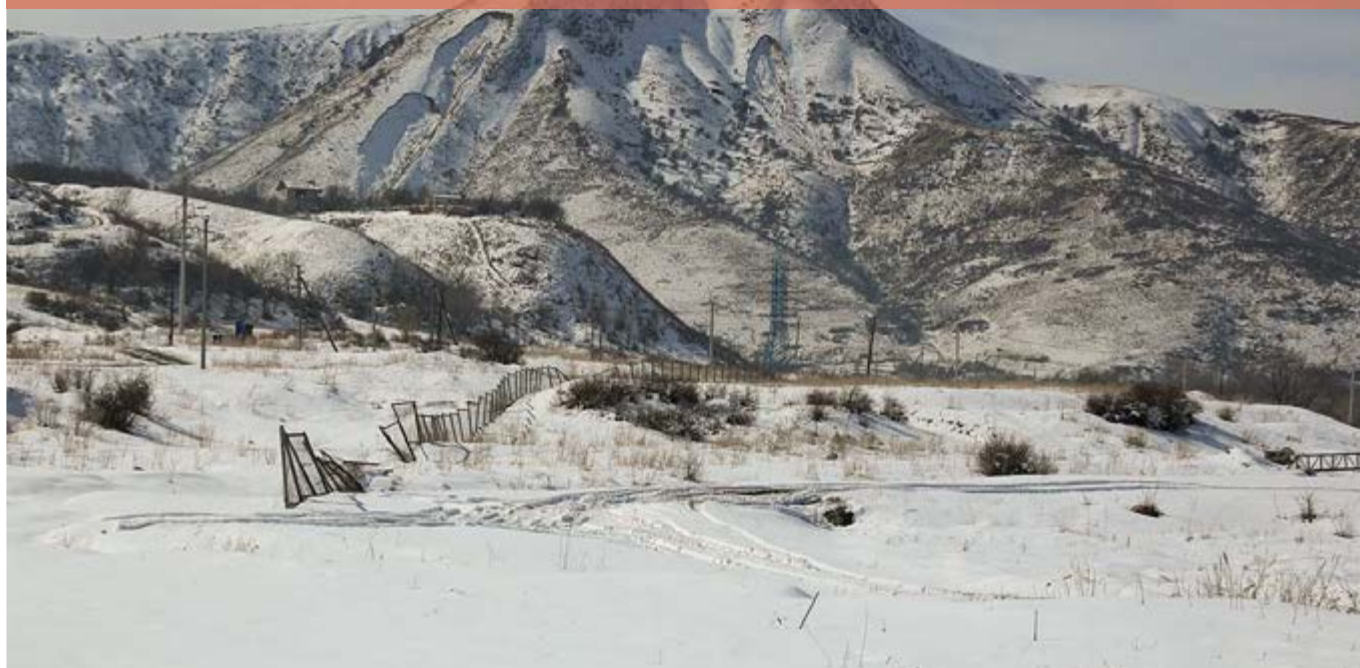
The fence was partially renovated in 2018 from the northern and eastern sides. From the south-eastern side the old fencing is partially broken or absent. From the southern and western side, there is still no fencing installed. Access to the site by foot or a vehicle from the south, southeast, and west is open.

Picture 17. Old fencing from the east side.
March 4, 2018.
