RESULTS OF 2018 MONITORING OF THE TALGAR WORLD HERITAGE SITE

Results of monitoring of the Talgar world heritage site: March – December 2018.

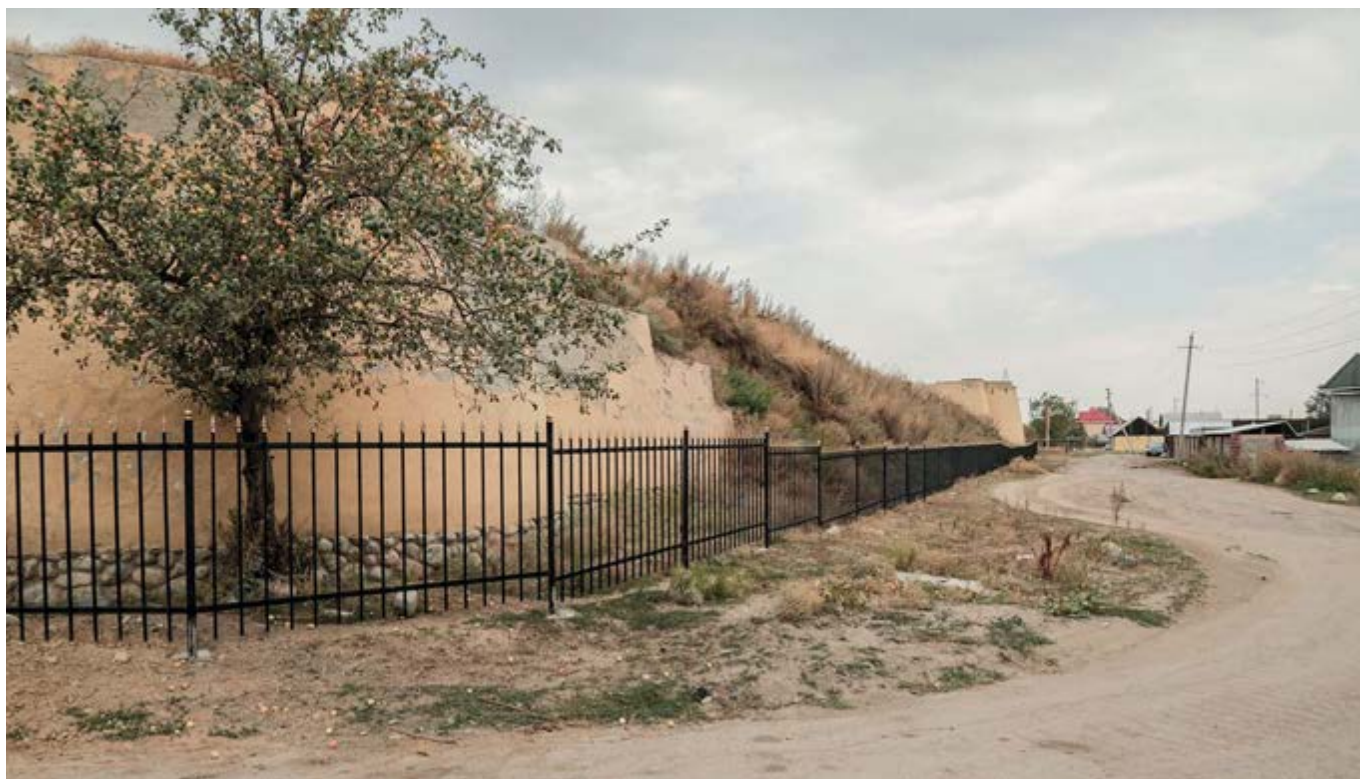
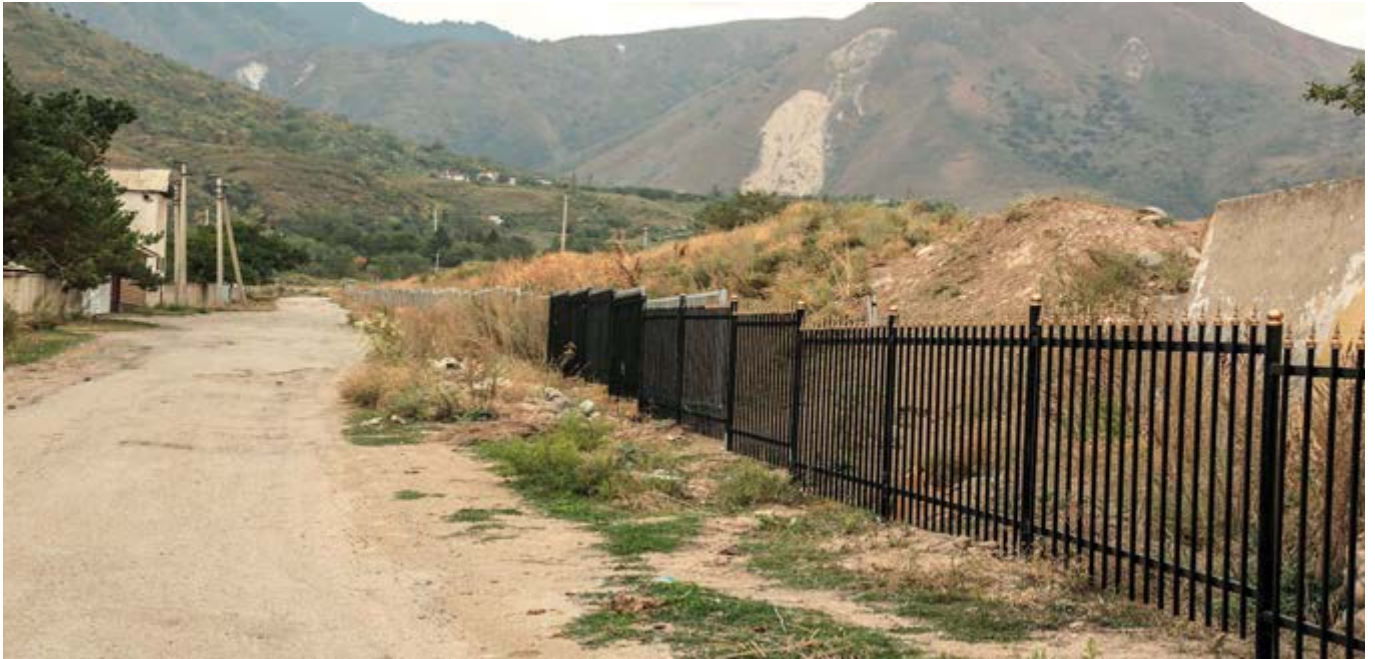
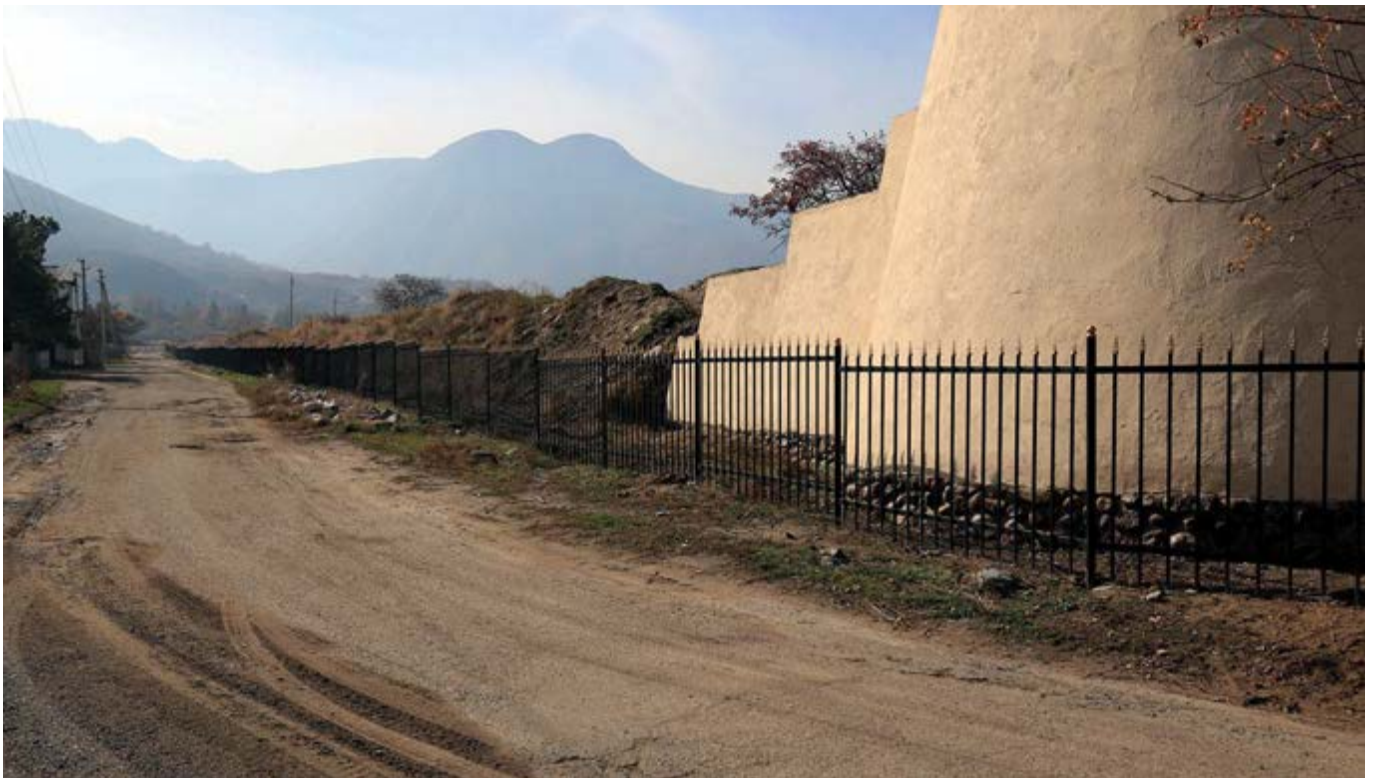
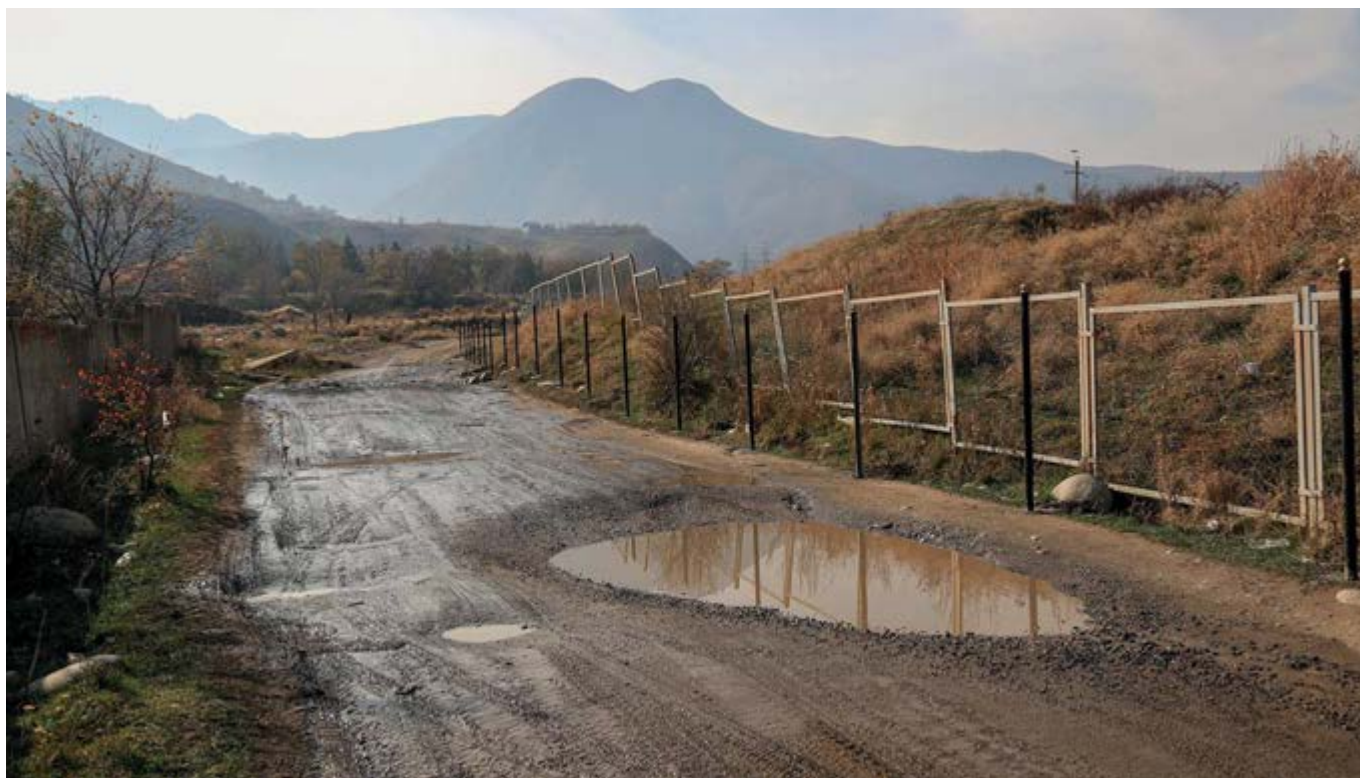
Picture 18. Installation of the new fencing is not completed.
September 10, 2018.

*Picture 19. **Installation of the new fencing is not completed.**
September 10, 2018.*

*Picture 20. **Installation of the new fencing is not completed.**
October 30, 2018.*

*Picture 21. **Installation of the new fencing is not completed.**
October 30, 2018.*

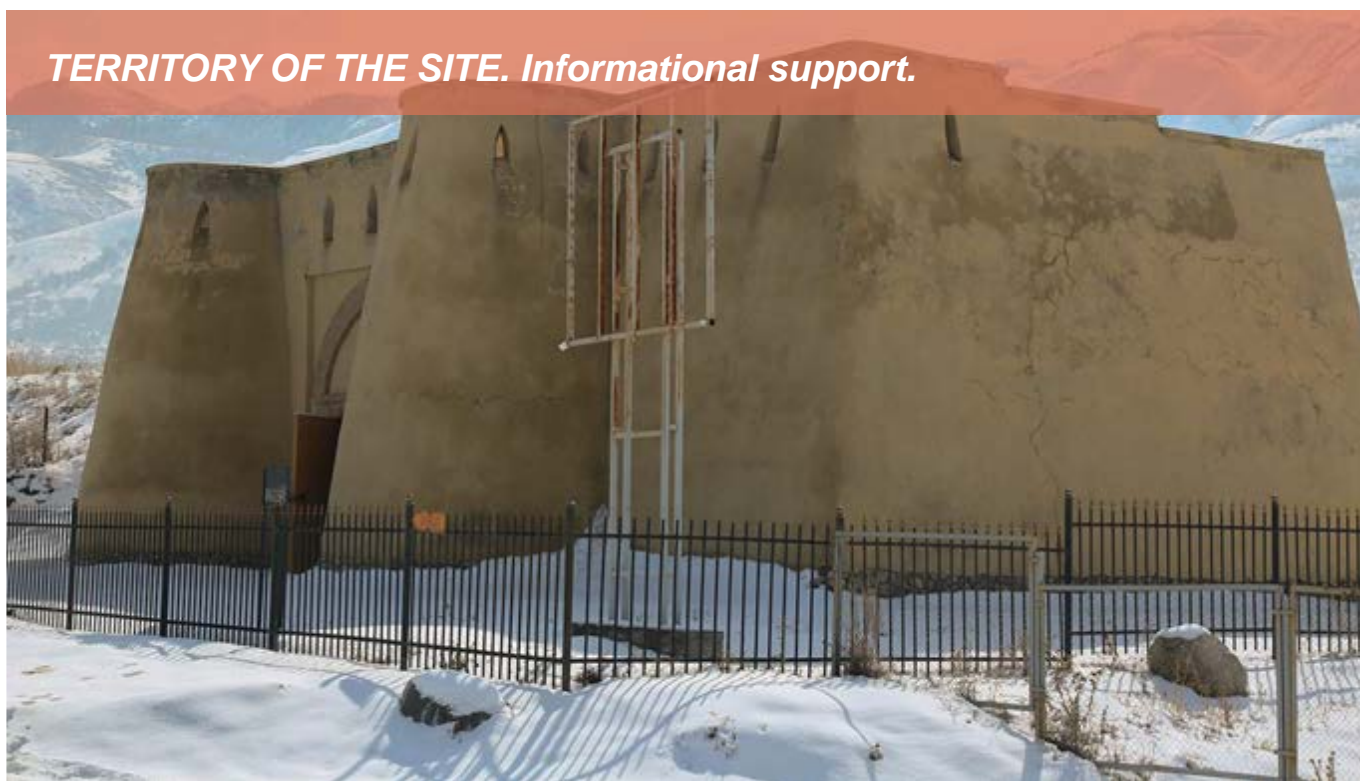
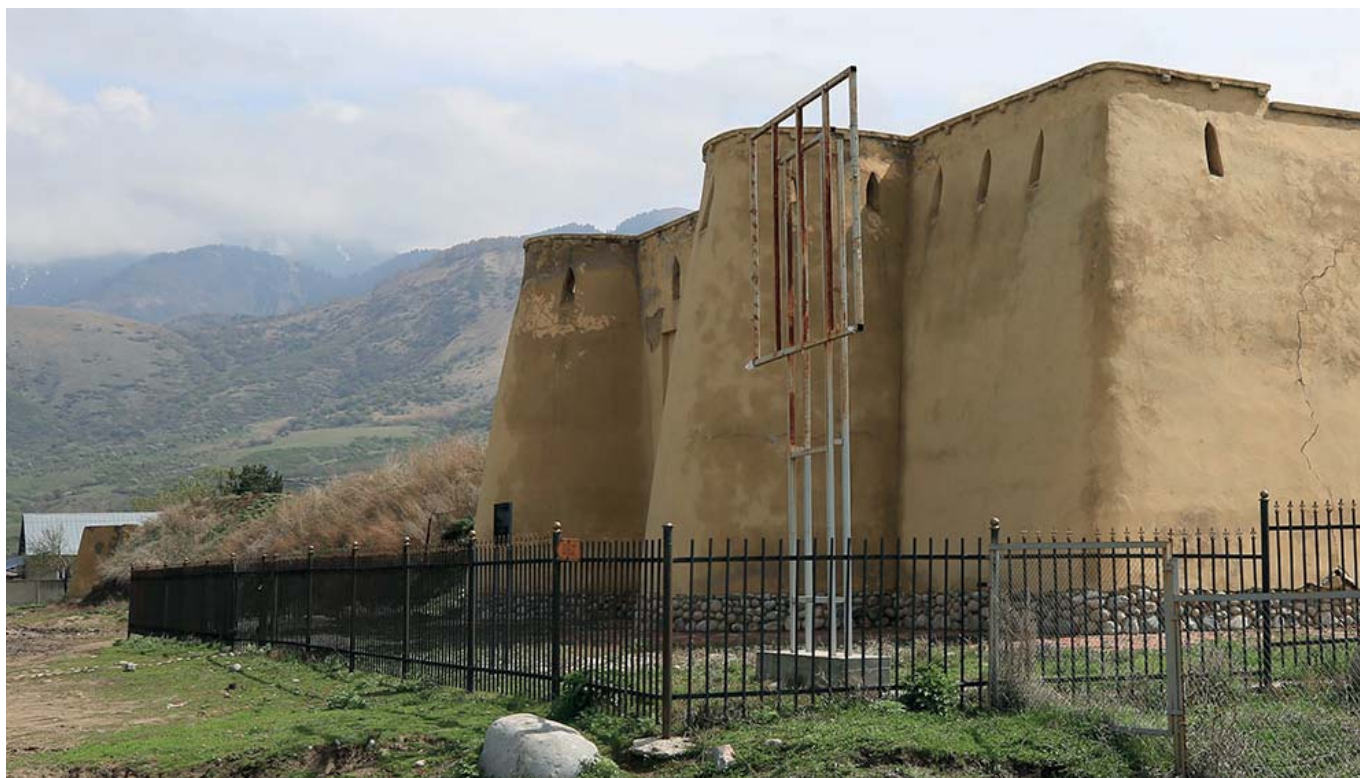
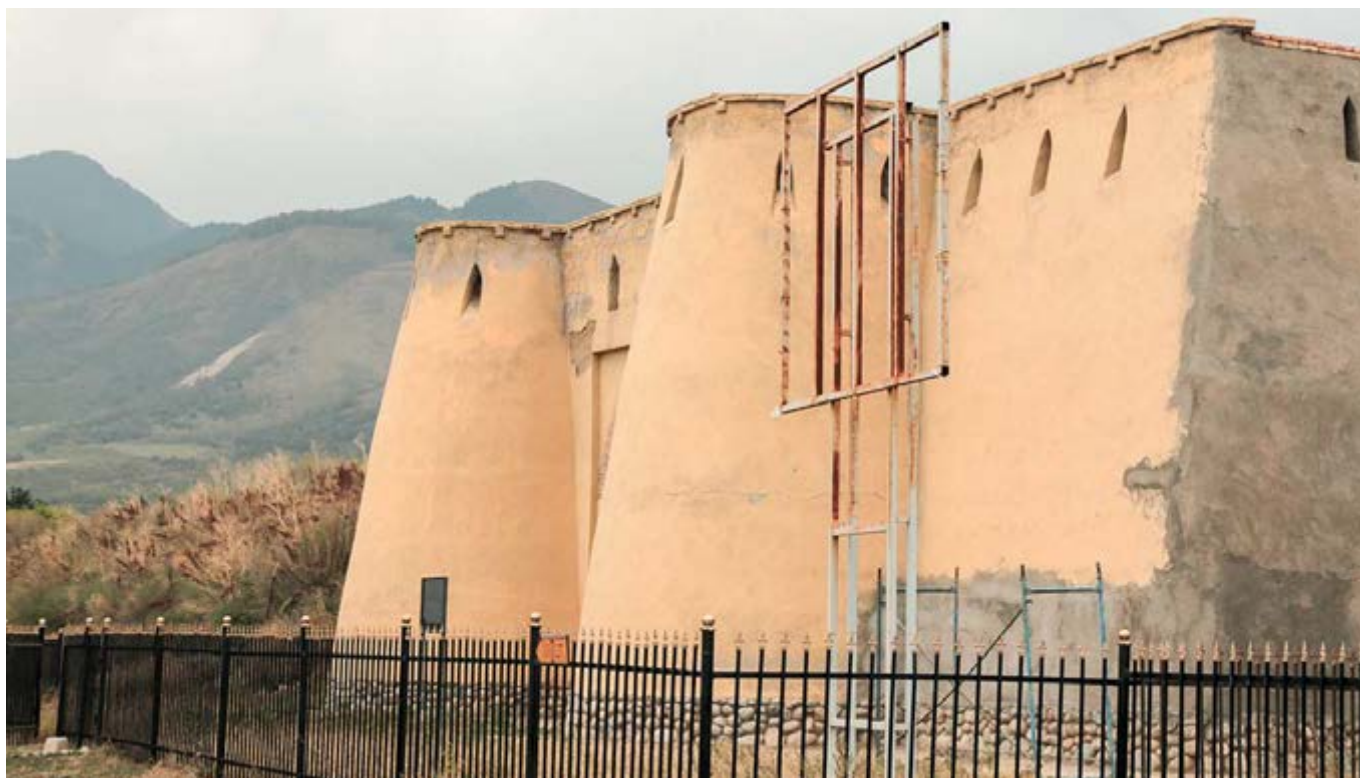
In the first half of the year, the informational stands remained empty. To the middle of the year, all stands except for the one at the entrance, were removed. Only in the second half of the year, the stand by the entrance was filled with information. In the other areas, no informational stands were installed, as of the end of the year.

*Picture 22. **Information board is empty.**
March 4, 2018.*

*Picture 23. **Information board is empty.**
April 17, 2018.*

*Picture 27. **Information board is empty.**
September 10, 2018.*

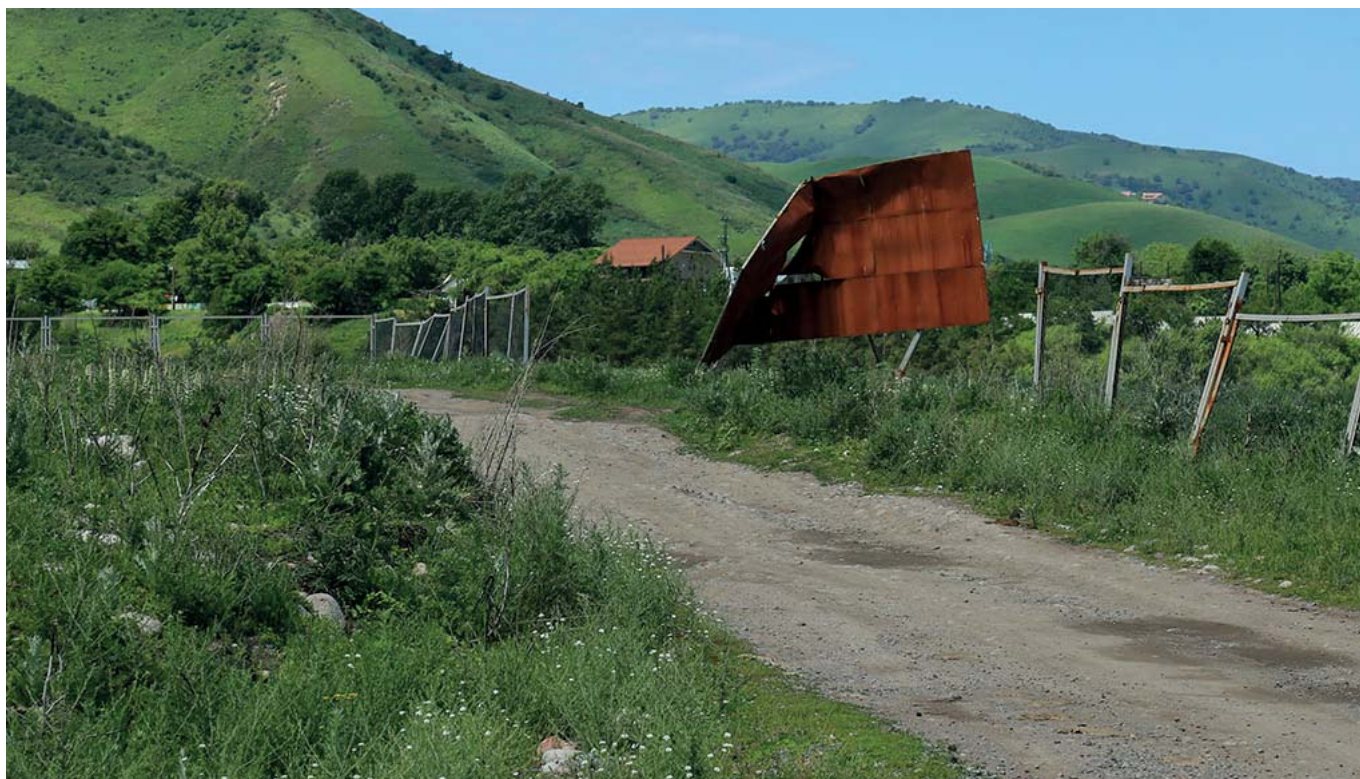
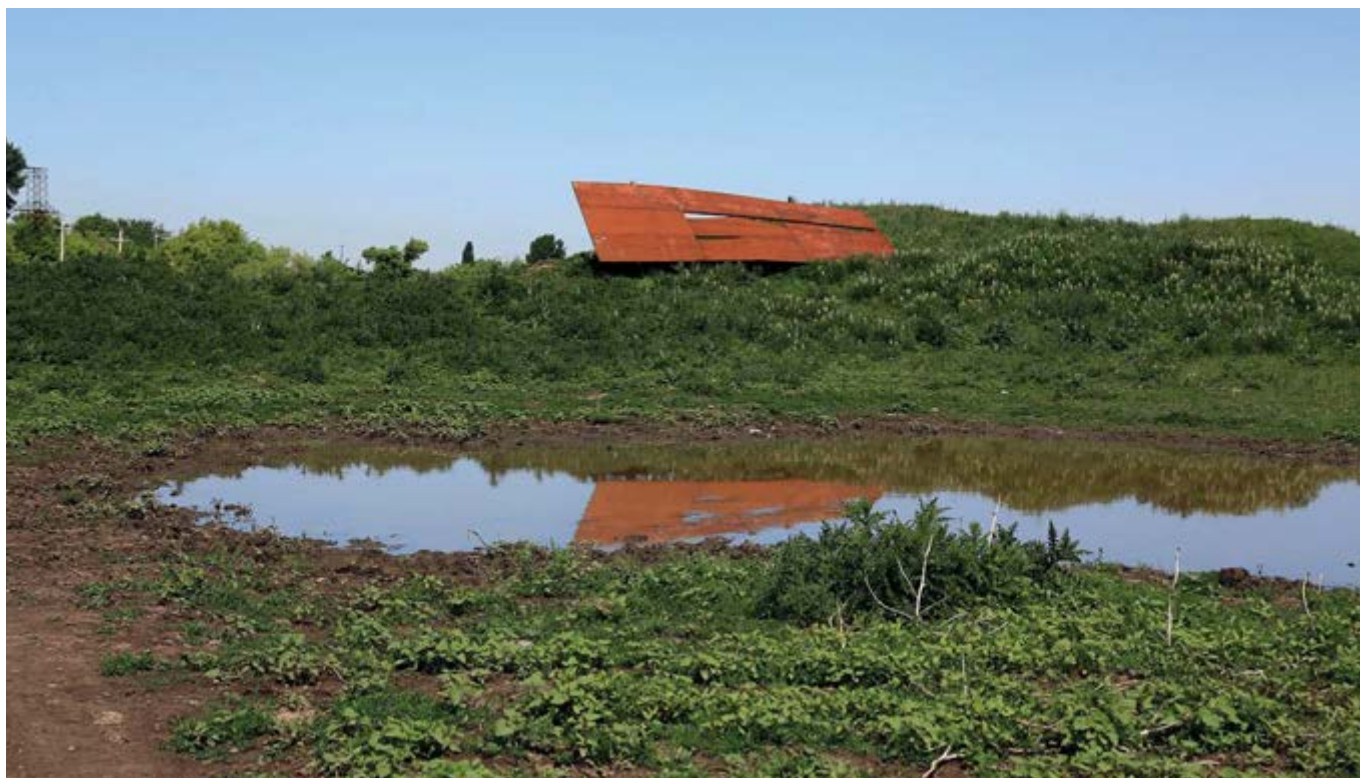
*Picture 24. **Broken information board.**
June 5, 2018.*

Picture 25. **Broken information board.**
June 5, 2018.

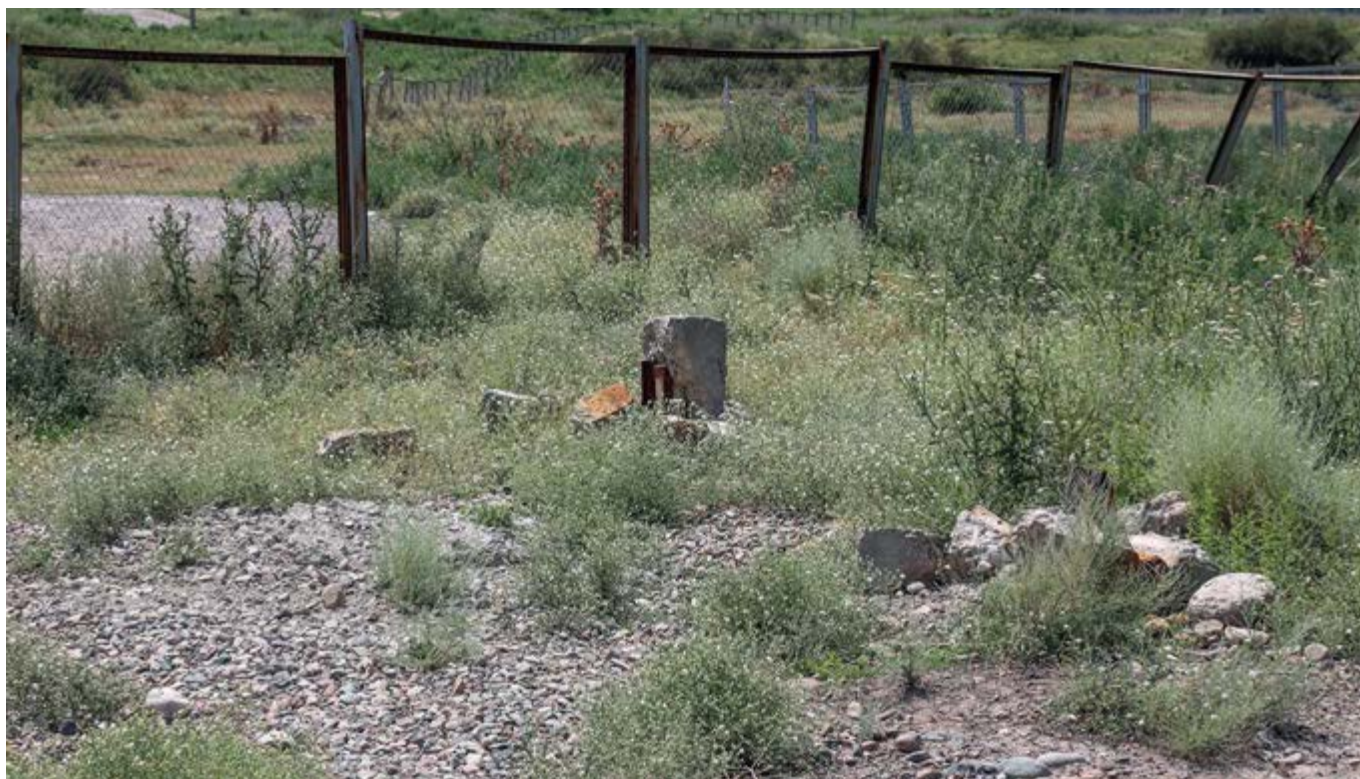
Picture 26. **Place where there used to be an information board.**
July 26, 2018.

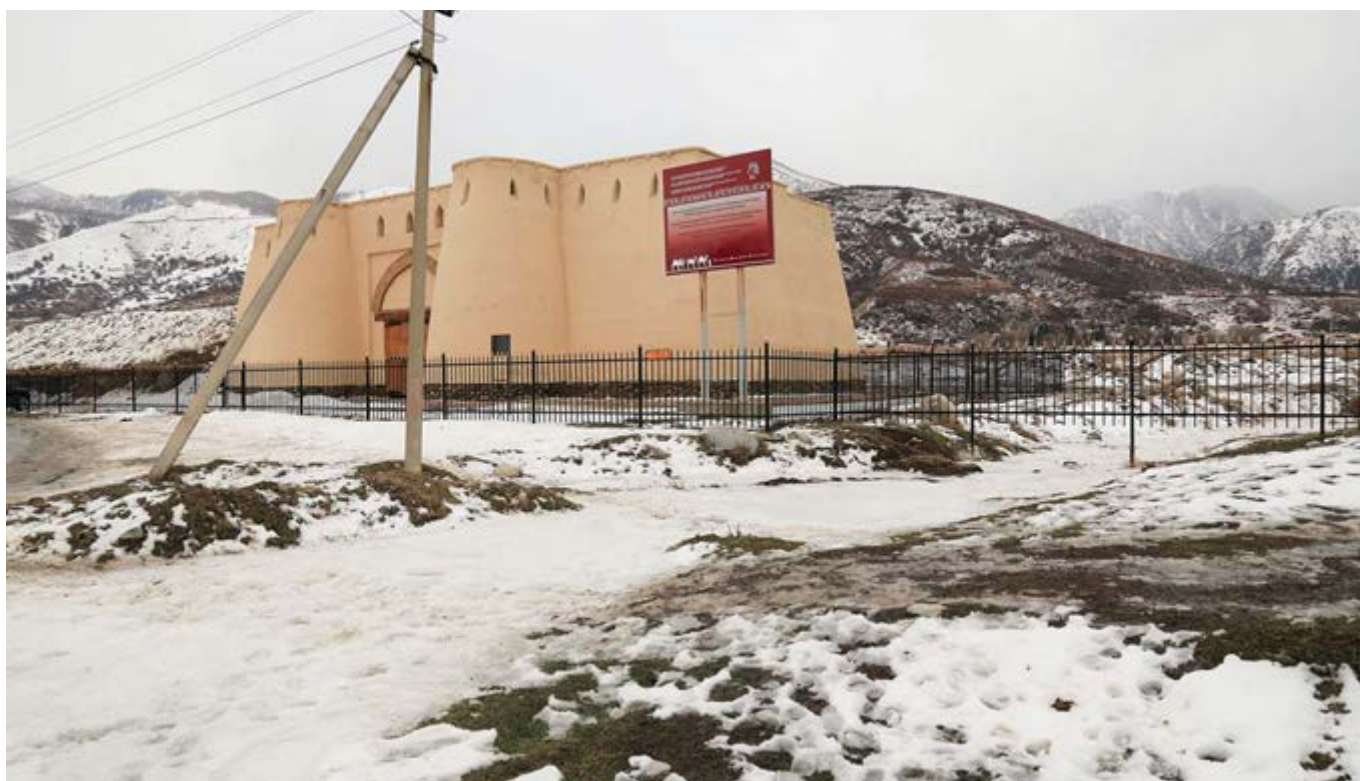
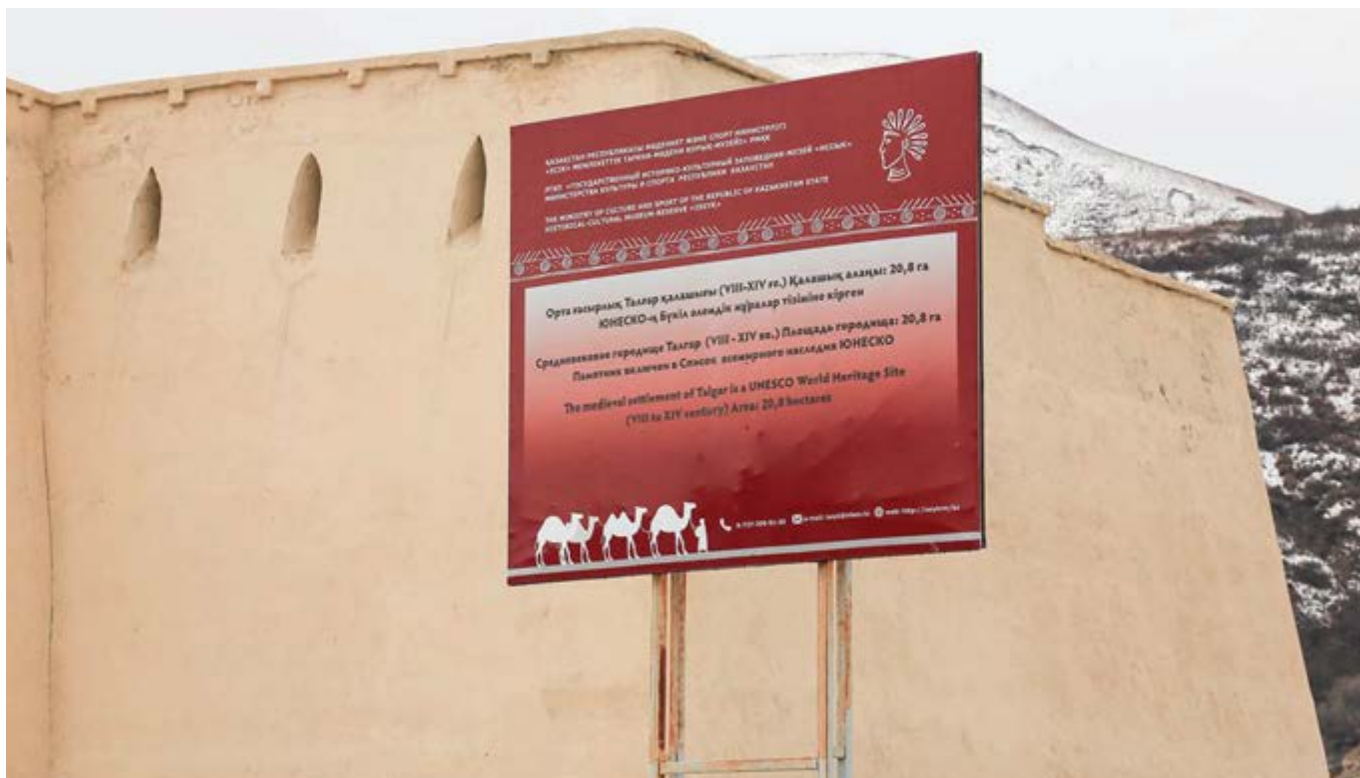
*Picture 28. **New information board.**
December 16, 2018.*

*Picture 29. New information board.
December 16, 2018.*

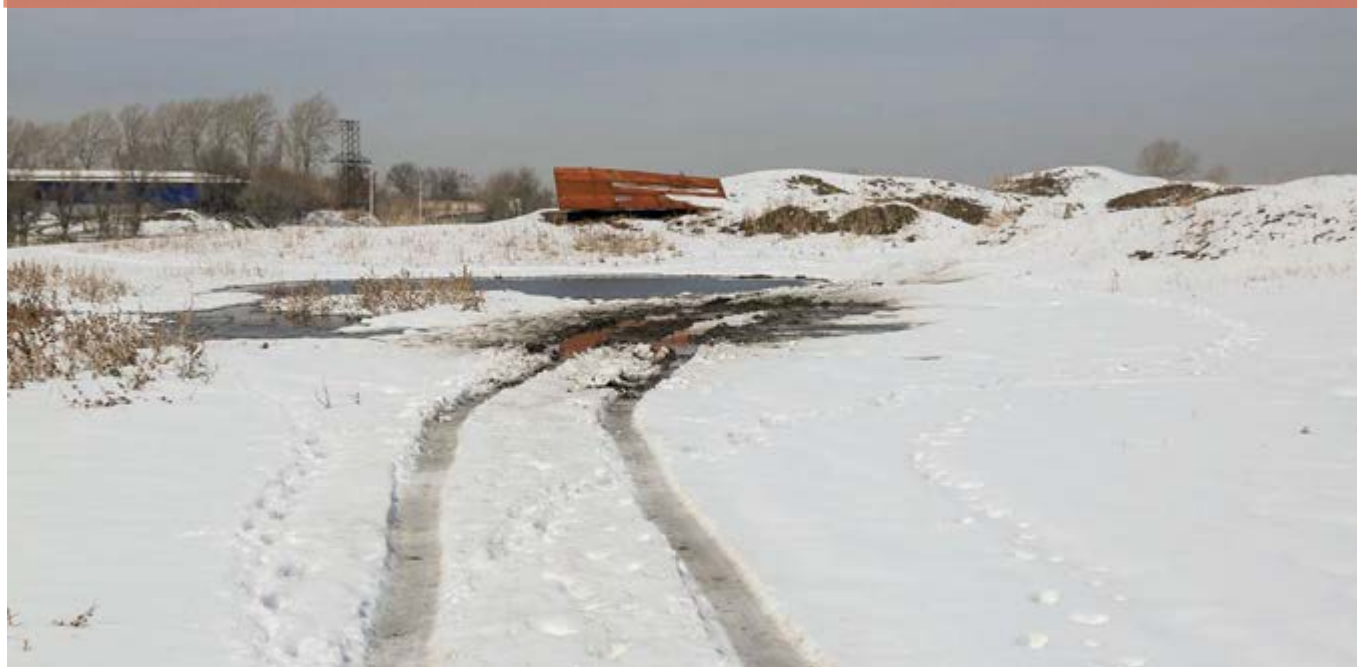
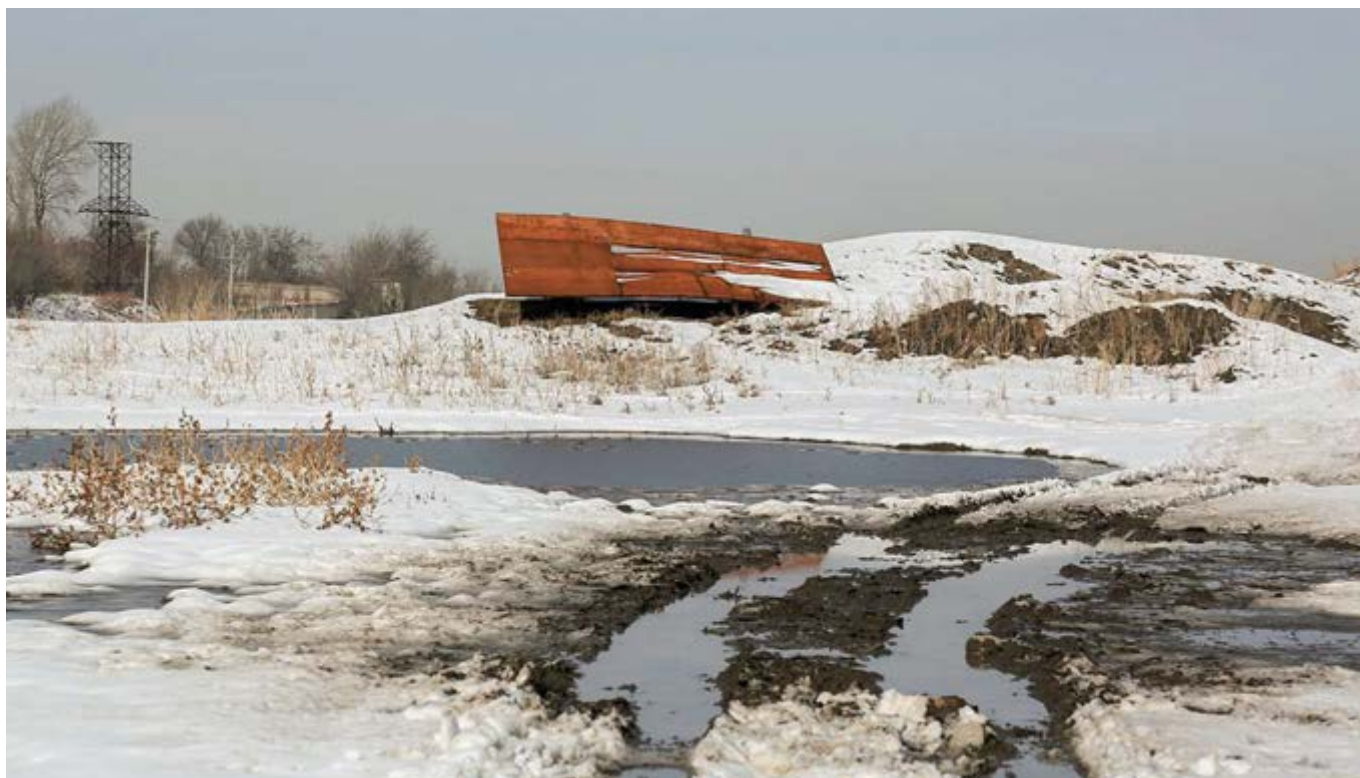
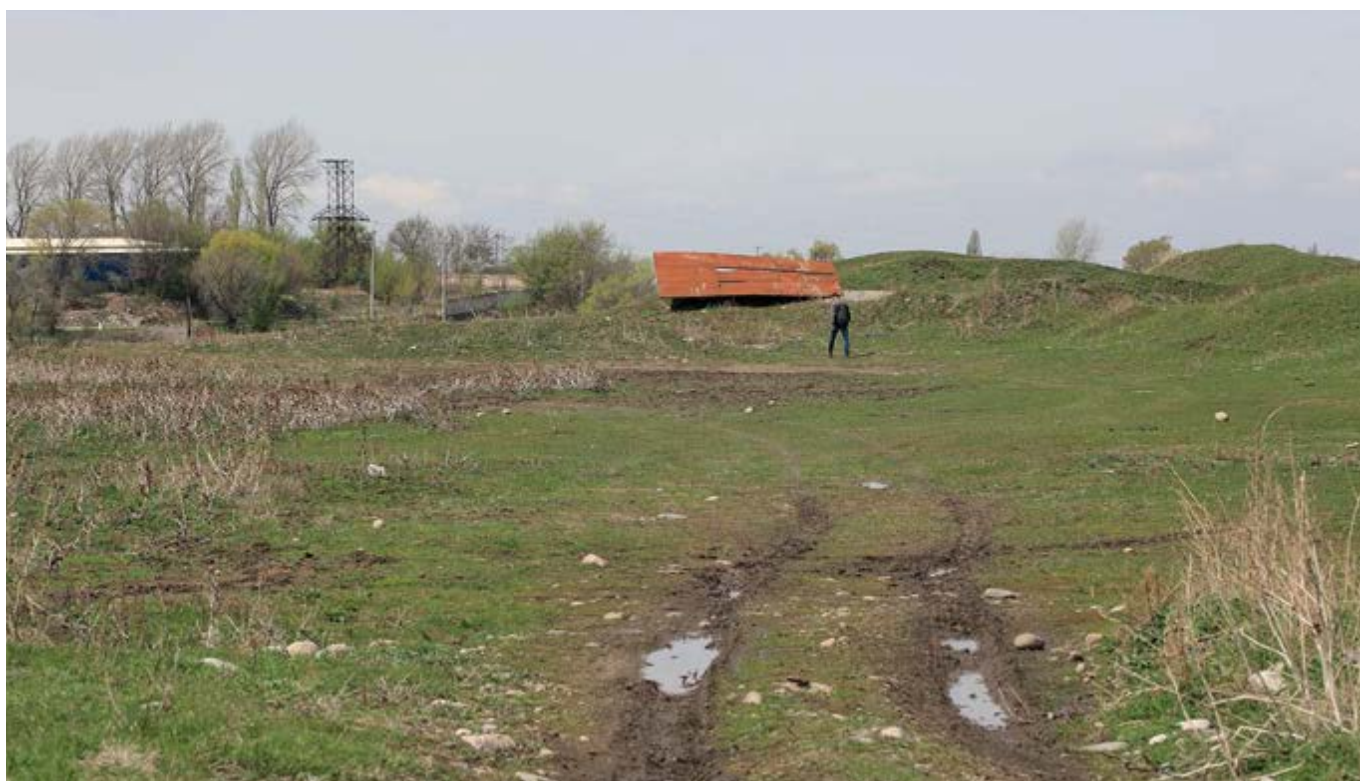
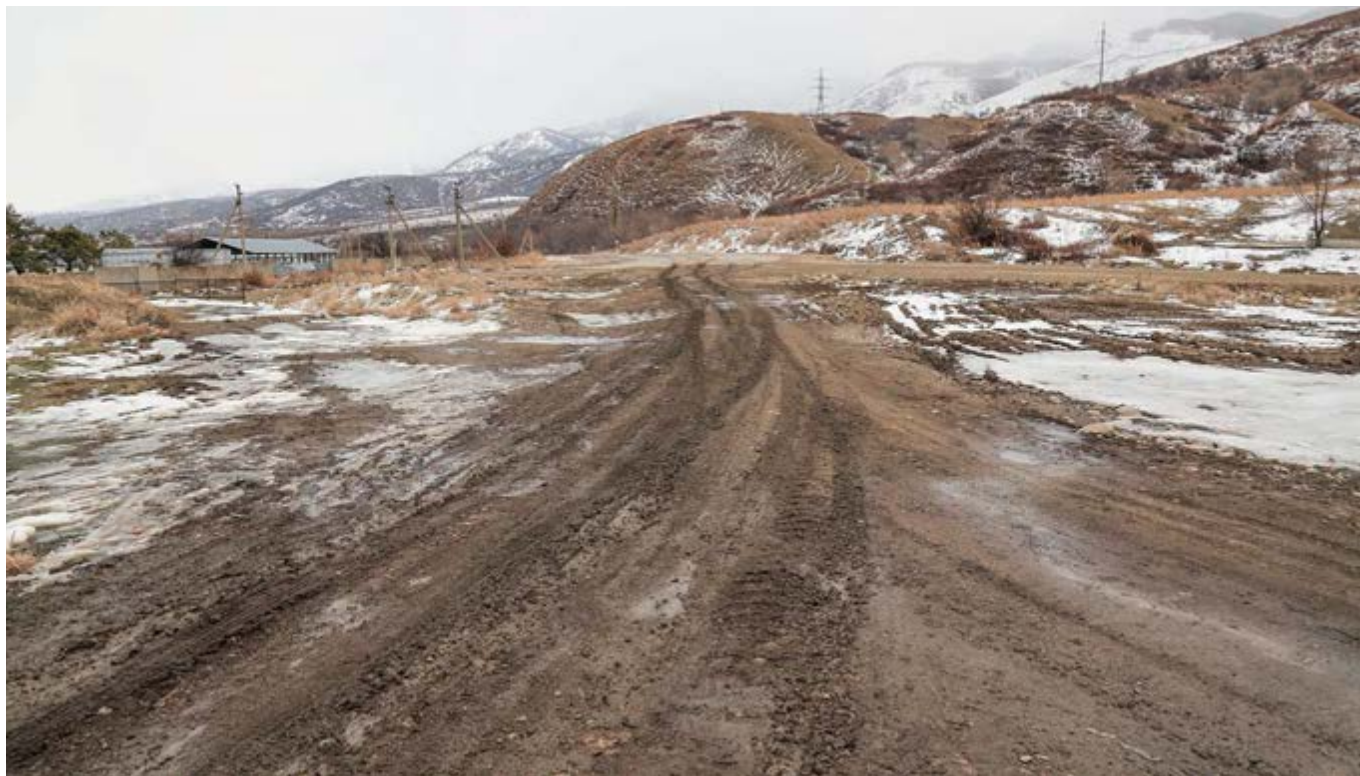
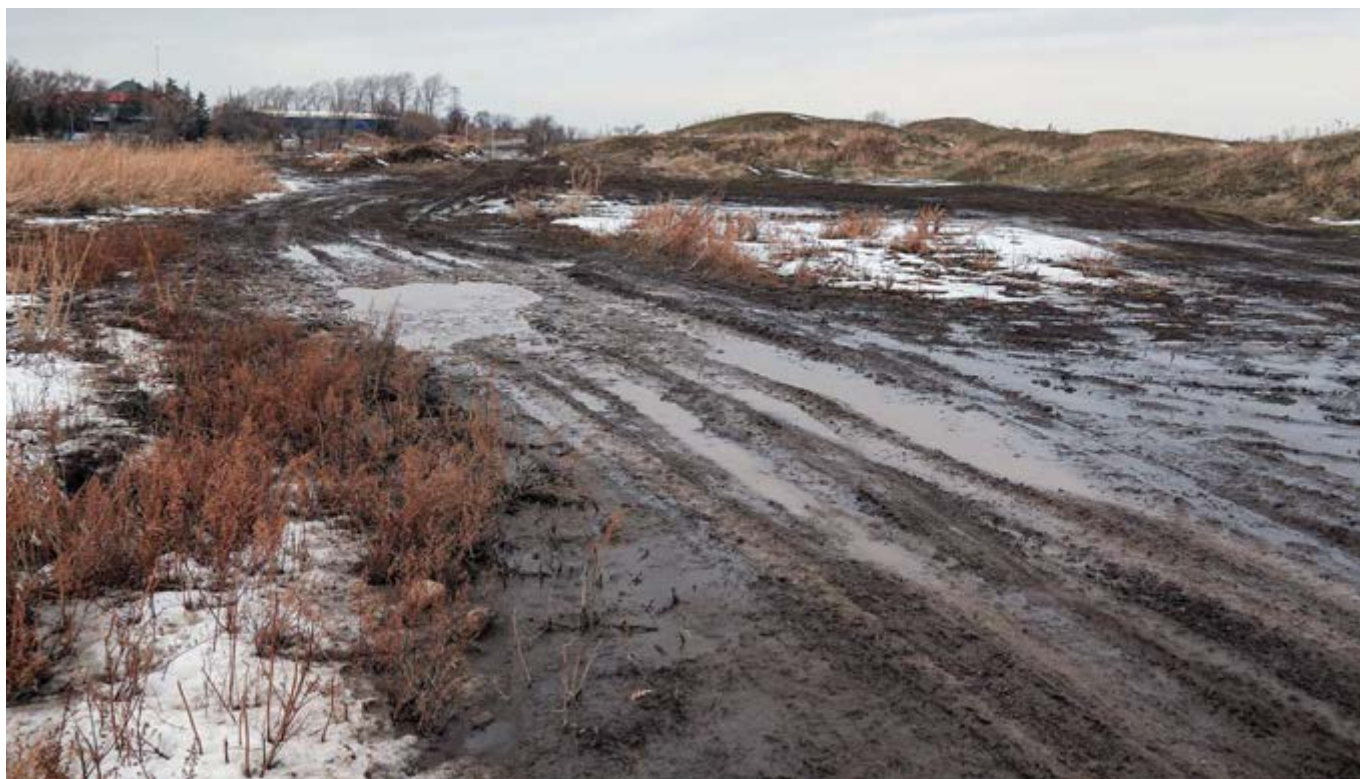
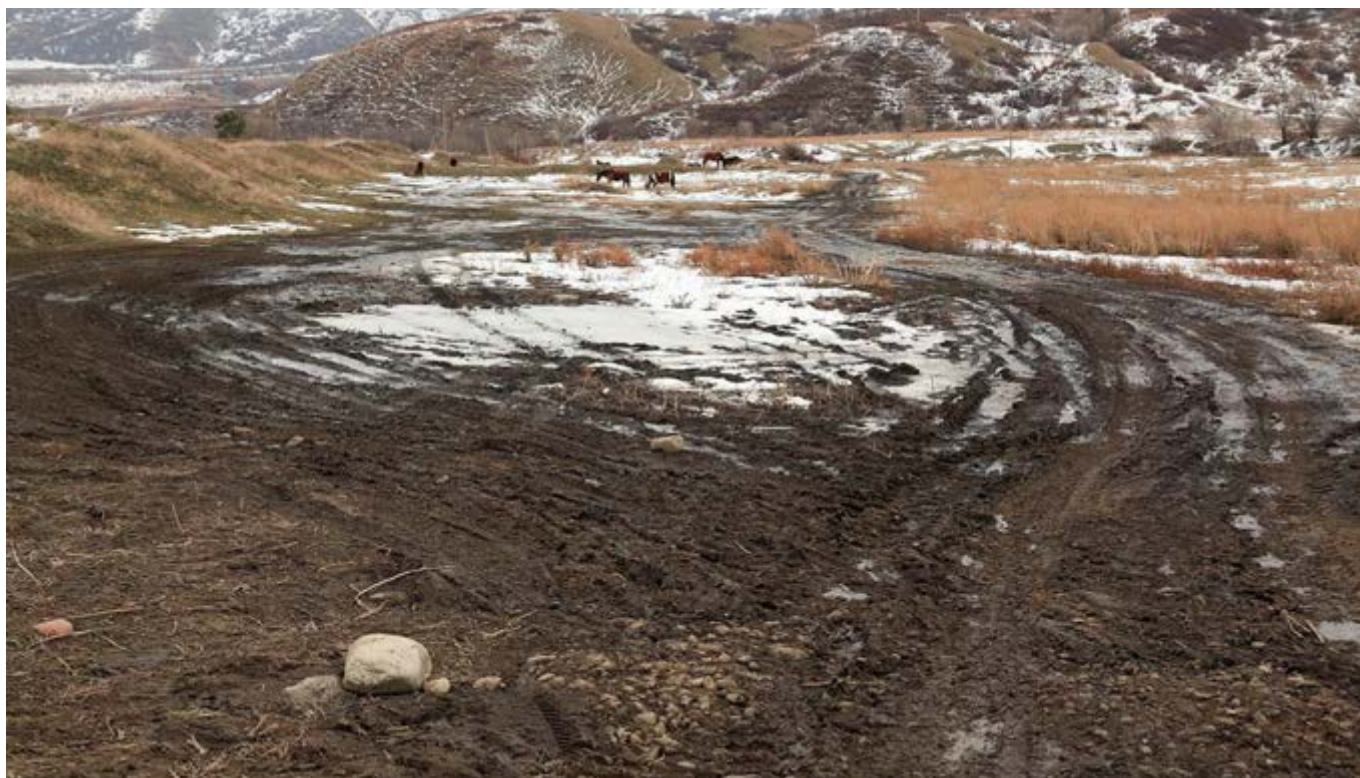
*Picture 30. Area excavated for the road bed.
March 4, 2018.*

*Picture 31. **Area excavated for the road bed.**
March 4, 2018.*

*Picture 32. **Area excavated for the road bed.**
April 17, 2018.*

*Picture 33. **Area excavated for the road bed.**
December 16, 2018.*

*Picture 34. **Area excavated for the road bed.**
December 16, 2018.*

*Picture 35. **Area excavated for the road bed.**
December 16, 2018.*

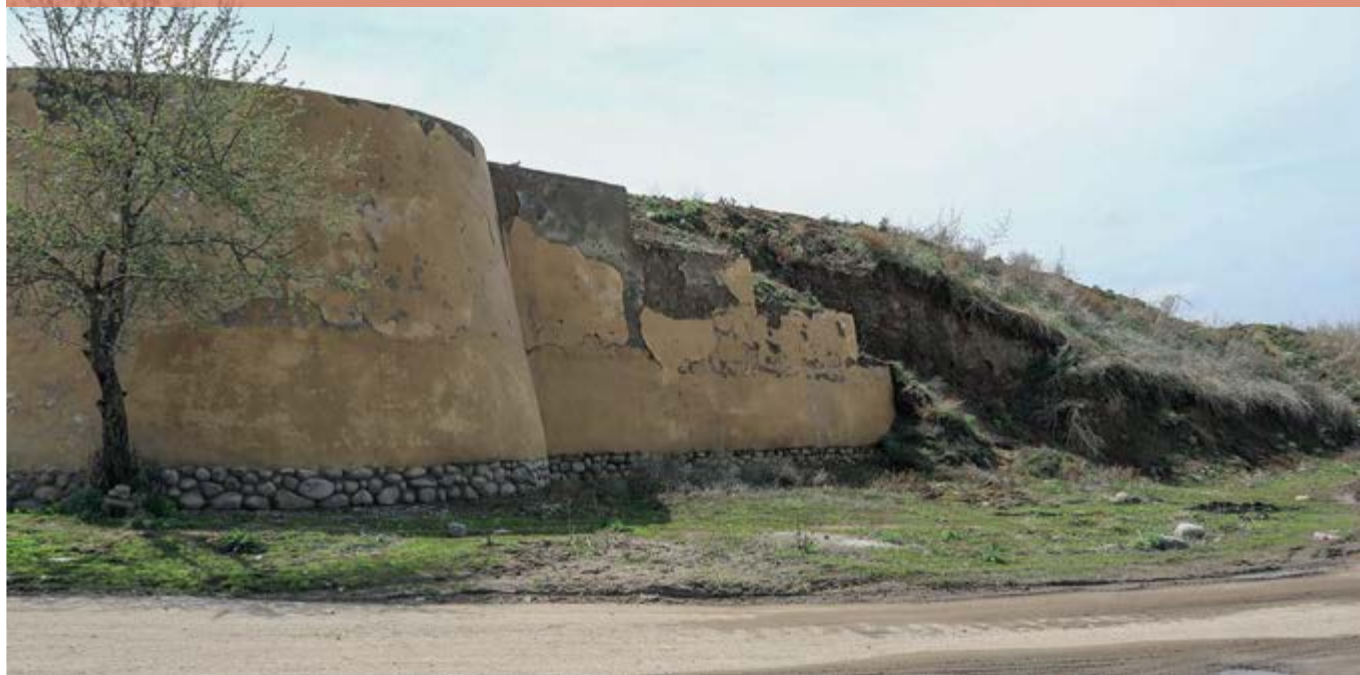
New reconstructions built on the site (entrance group and corner citadel) were severely deteriorated. In summer, reconstruction works started. It ended up being a simple patching of the falling apart entrance group. Construction materials and waste generated during the works was dumped on the territory of the monument. Judging by the reconstruction, it was carried out without any scientific approach.

*Picture 36. **Deteriorating corner tower and rampart that is being washed off.**
April 17, 2018.*

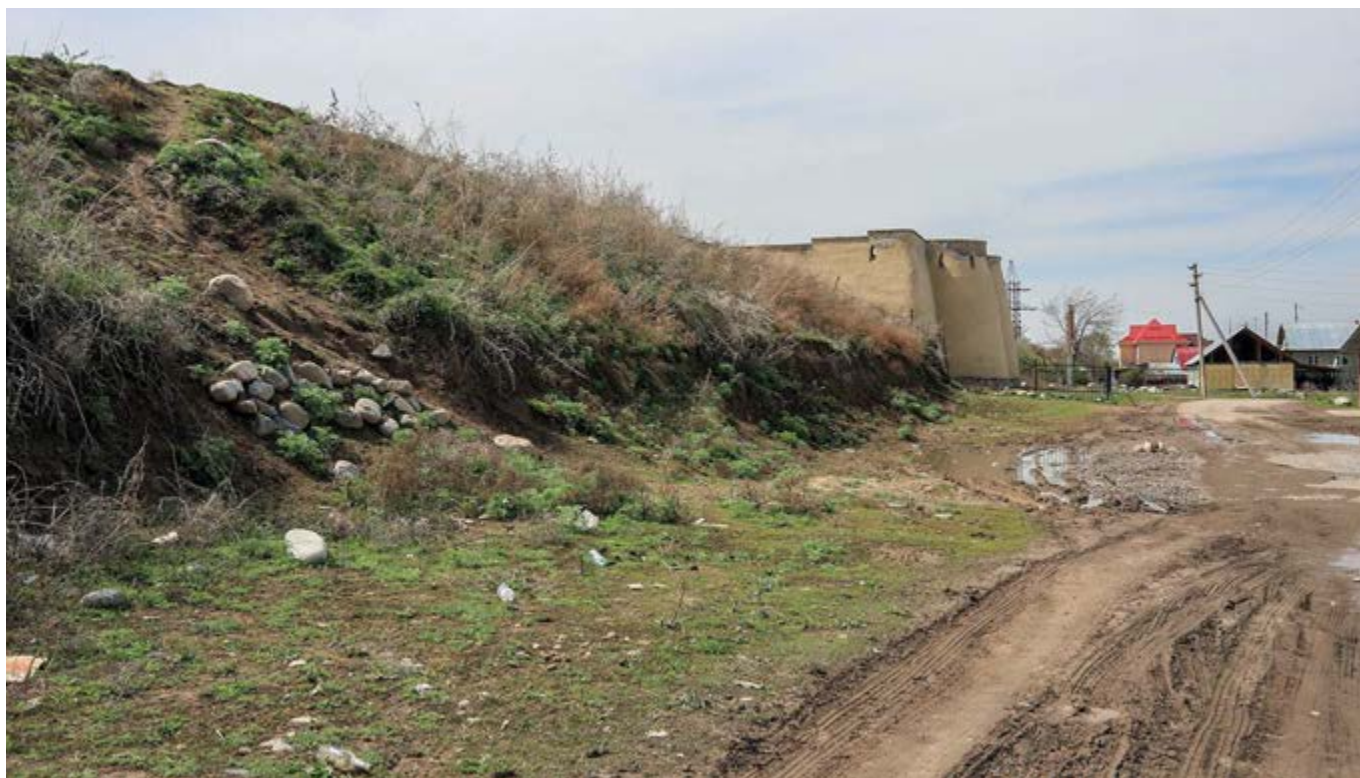
*Picture 37. **Washed off rampart where there used to be a pit.**
April 17, 2018.*
