RESULTS OF 2018 MONITORING OF THE TALGAR WORLD HERITAGE SITE

Results of monitoring of the Talgar world heritage site: March – December 2018.

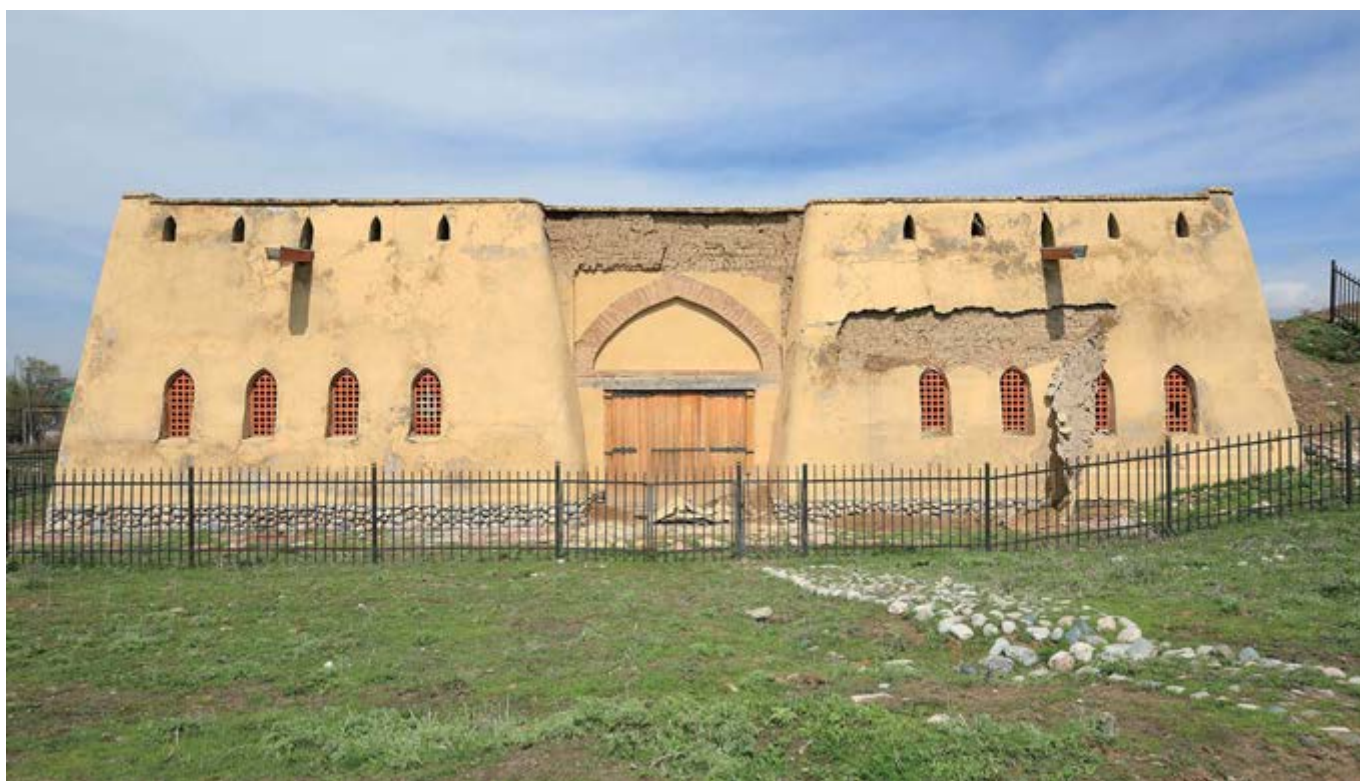
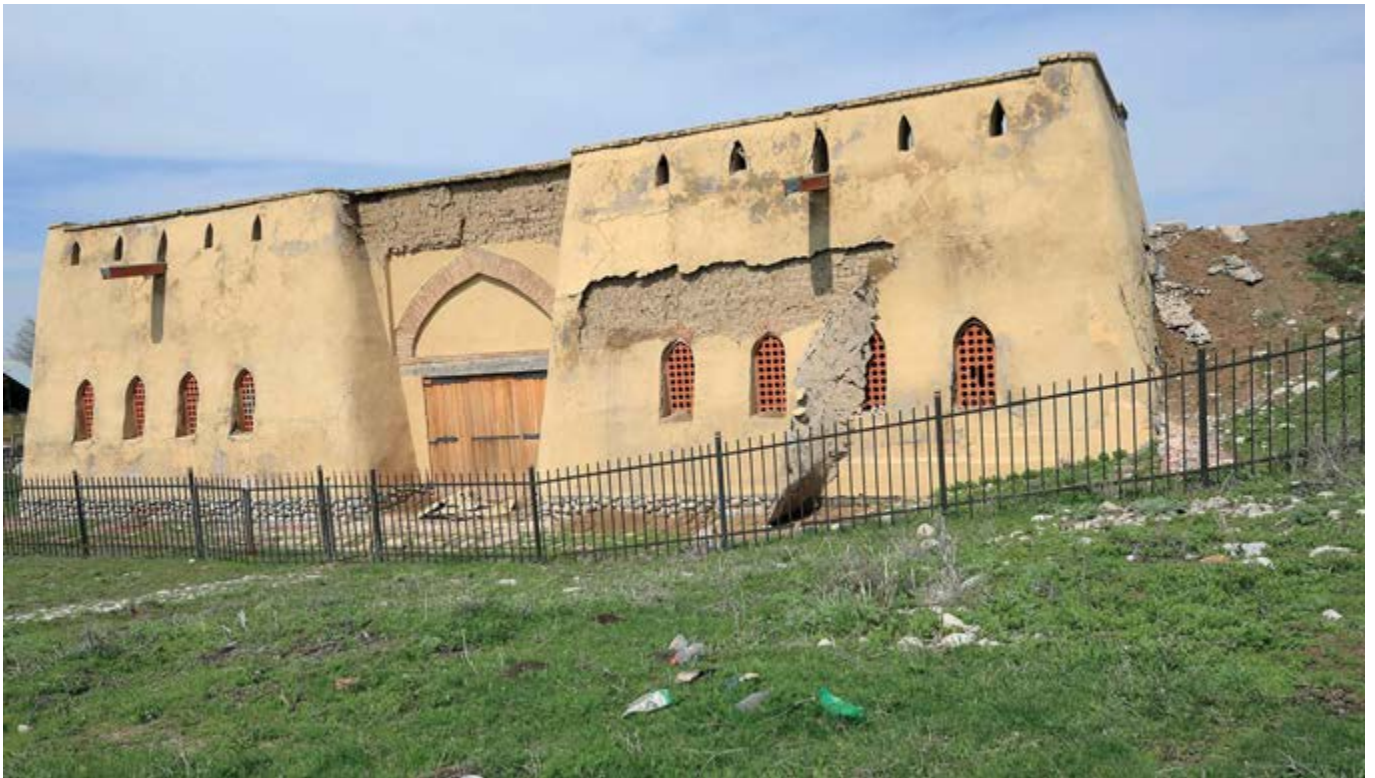
New reconstructions built on the site (entrance group and corner citadel) were severely deteriorated. In summer, reconstruction works started. It ended up being a simple patching of the falling apart entrance group. Construction materials and waste generated during the works was dumped on the territory of the monument. Judging by the reconstruction, it was carried out without any scientific approach.

*Picture 38. **Deteriorating entrance group.**
April 17, 2018.*

*Picture 39. **Deteriorating entrance group and trash.**
April 17, 2018.*

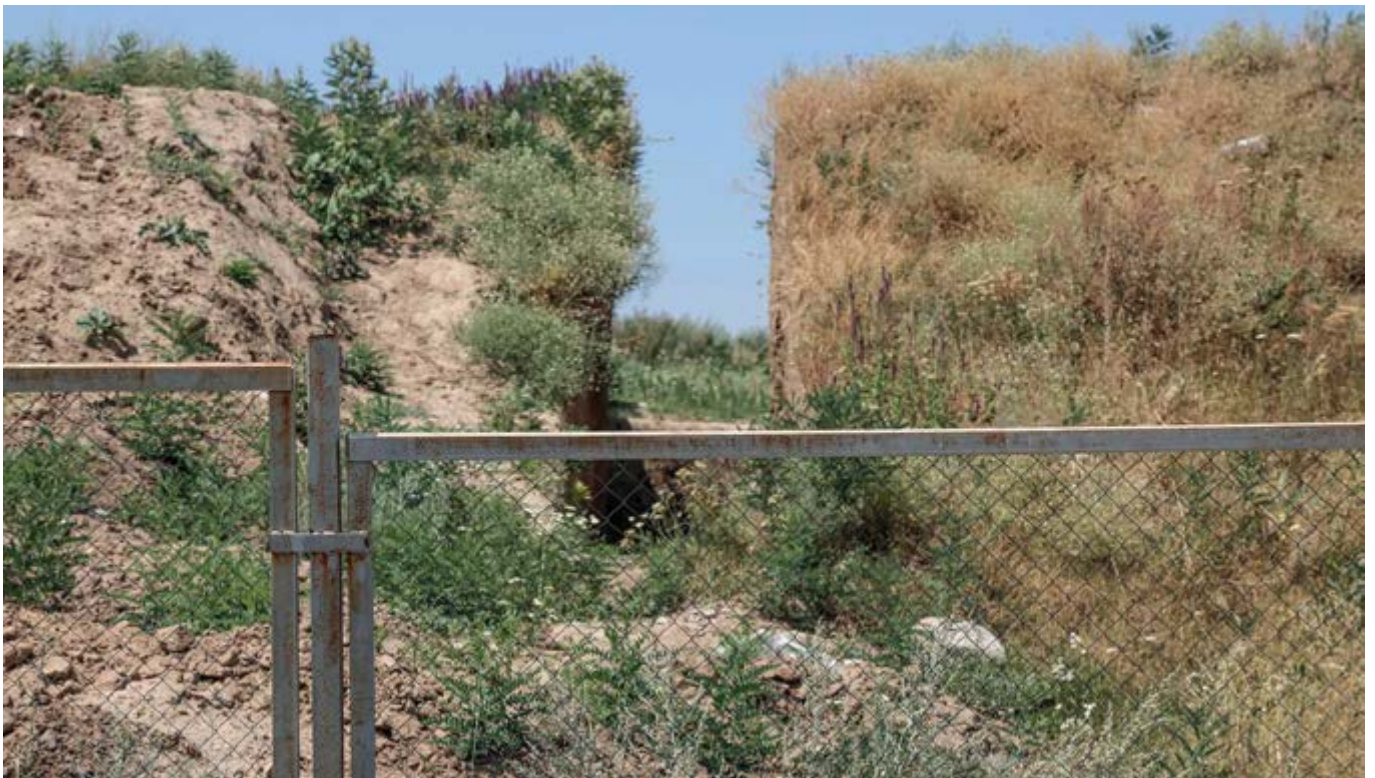
In the eastern part of the site, new excavations were carried out, as a result of which the rampart was damaged in one more area.

*Picture 40. **In summer 2018, one more area of the rampart was destroyed.**
July 26, 2018.*

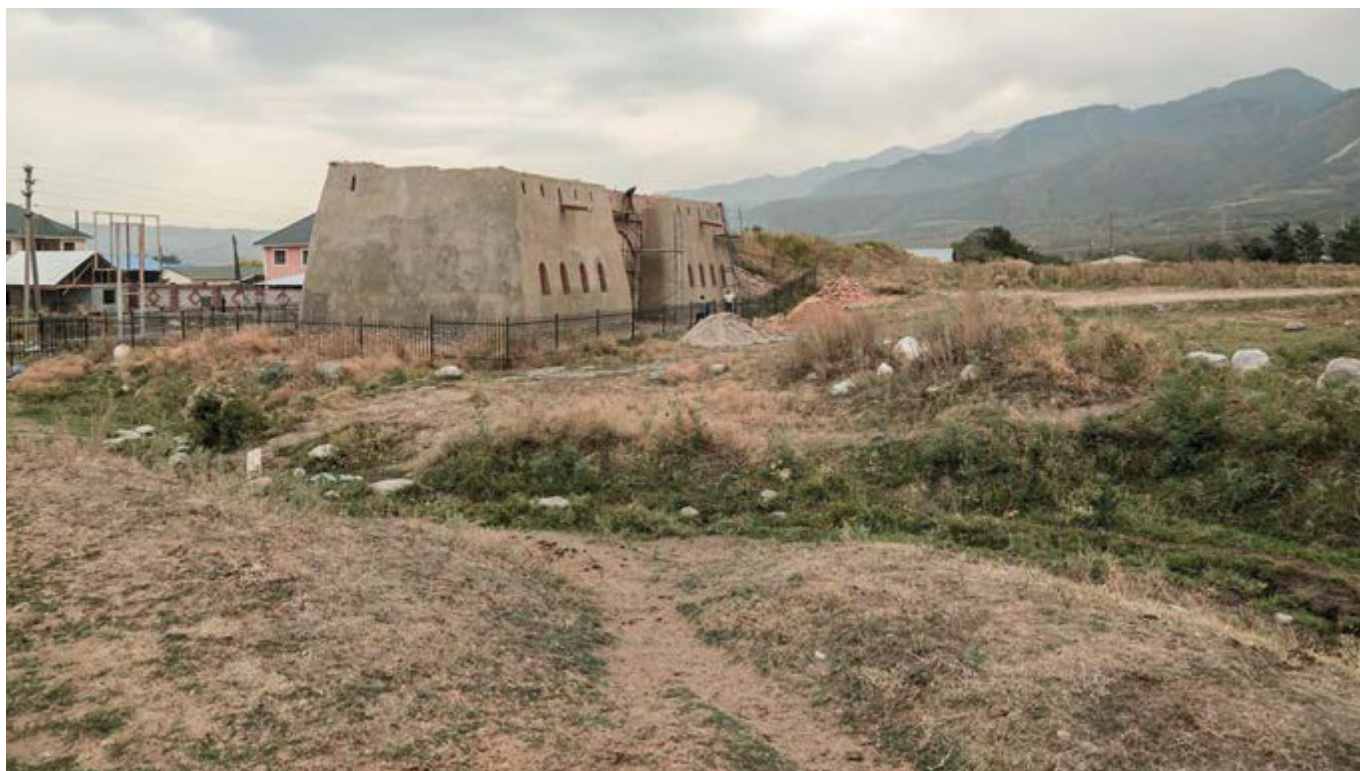
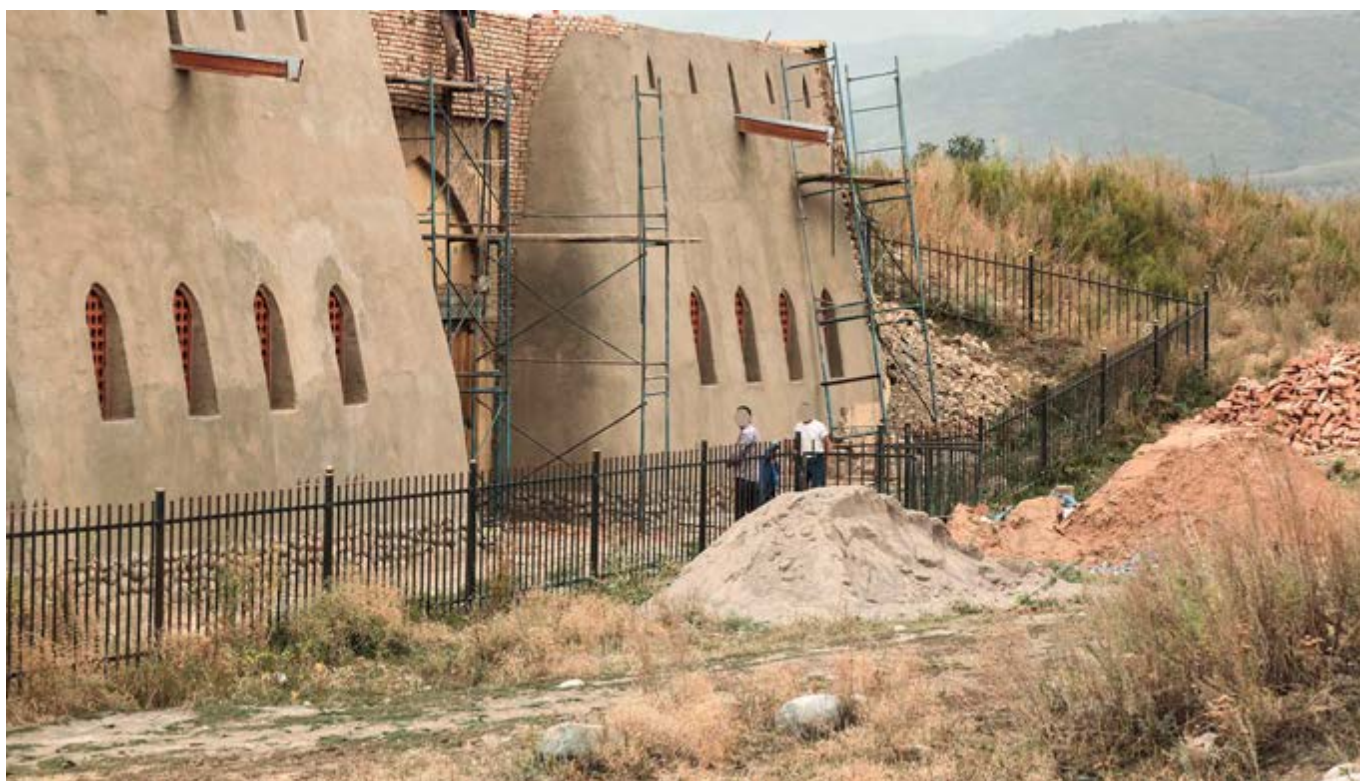
Picture 41. During the reconstruction, the construction materials were dumped on the territory of the hillfort.
September 10, 2018.

Picture 42. During the reconstruction, the construction materials were dumped on the territory of the hillfort.
September 10, 2018.

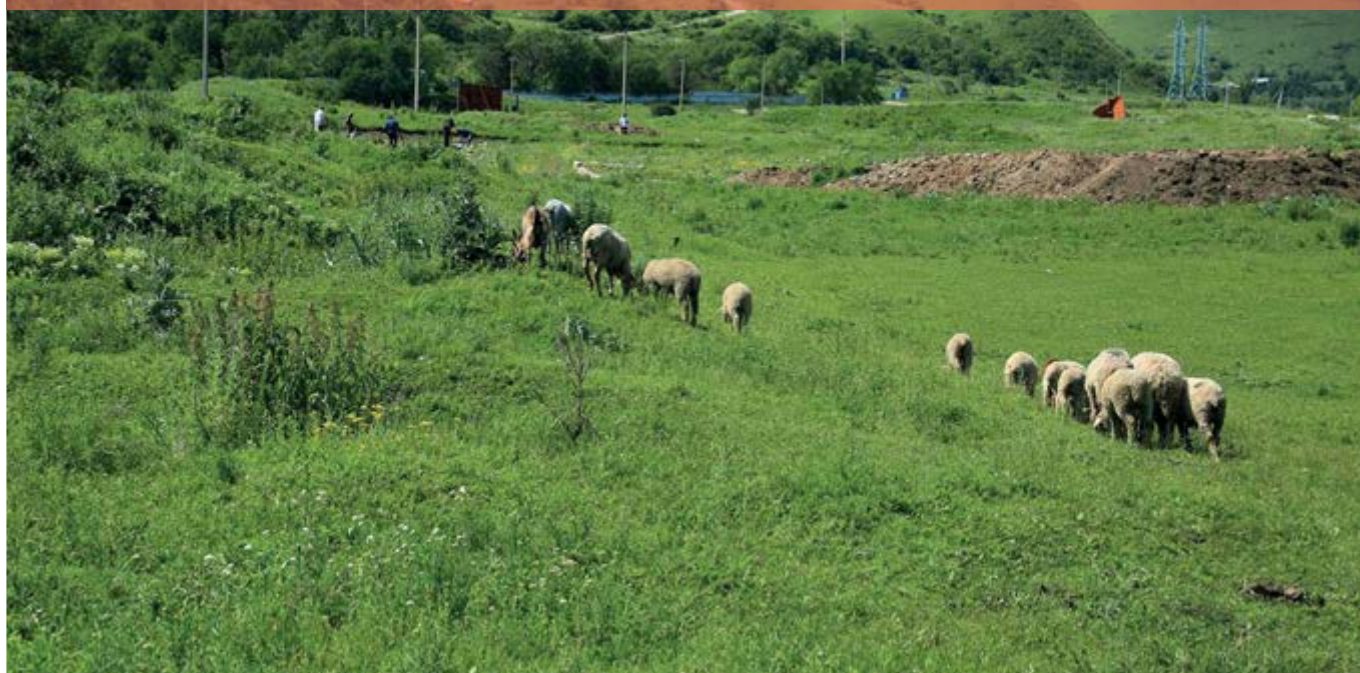
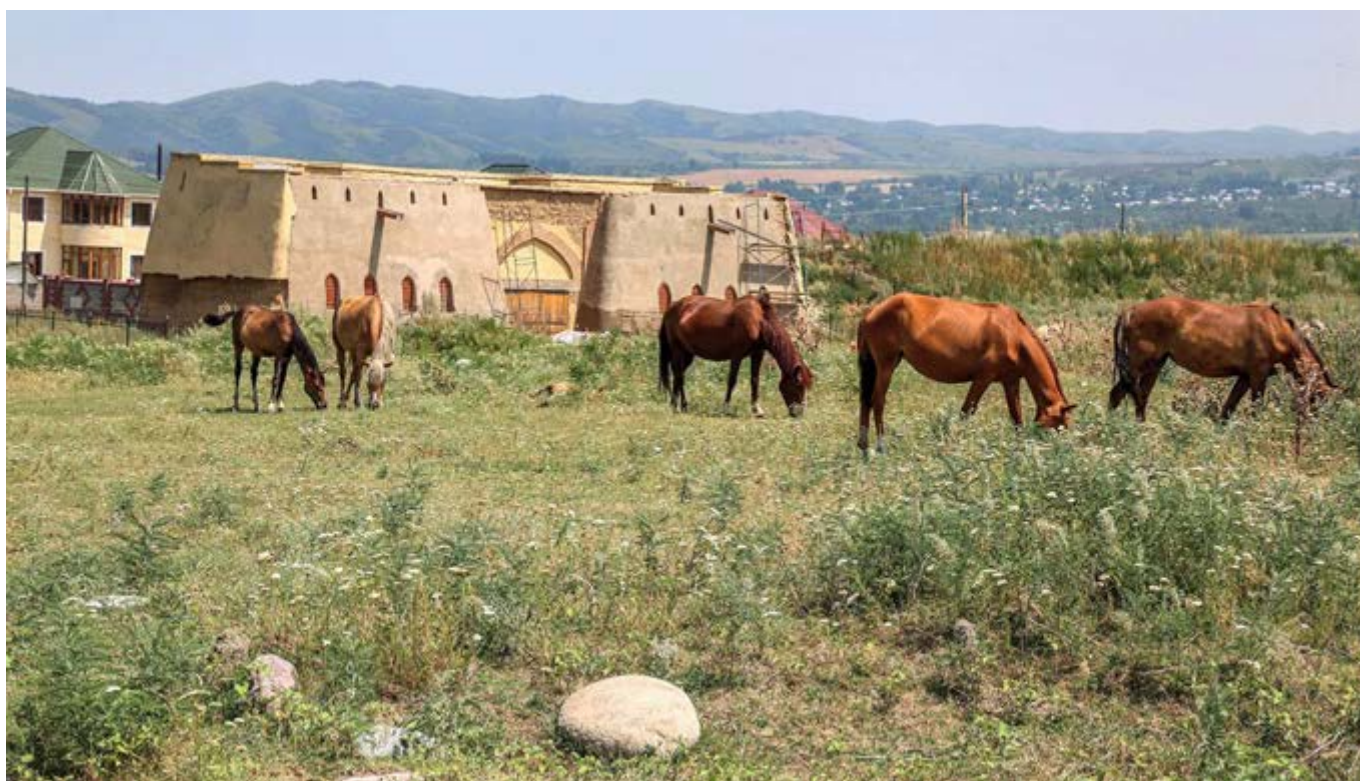
Picture 43. Livestock grazing.
June 5, 2018.

Picture 44. Livestock grazing.
July 26, 2018.

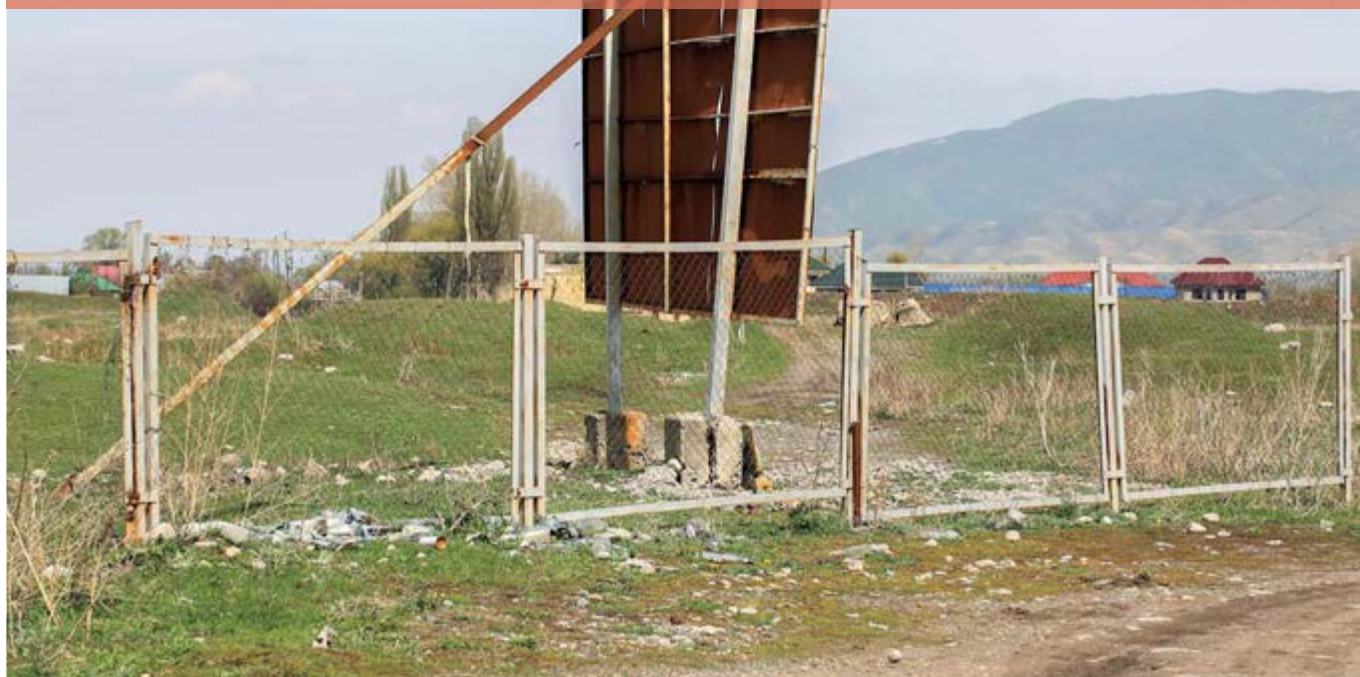
Household waste is scattered throughout the whole territory. Building structures debris laying around the hillfort for many years are still not removed.

*Picture 45. **Household waste is scattered throughout the whole territory.**
April 17, 2018.*

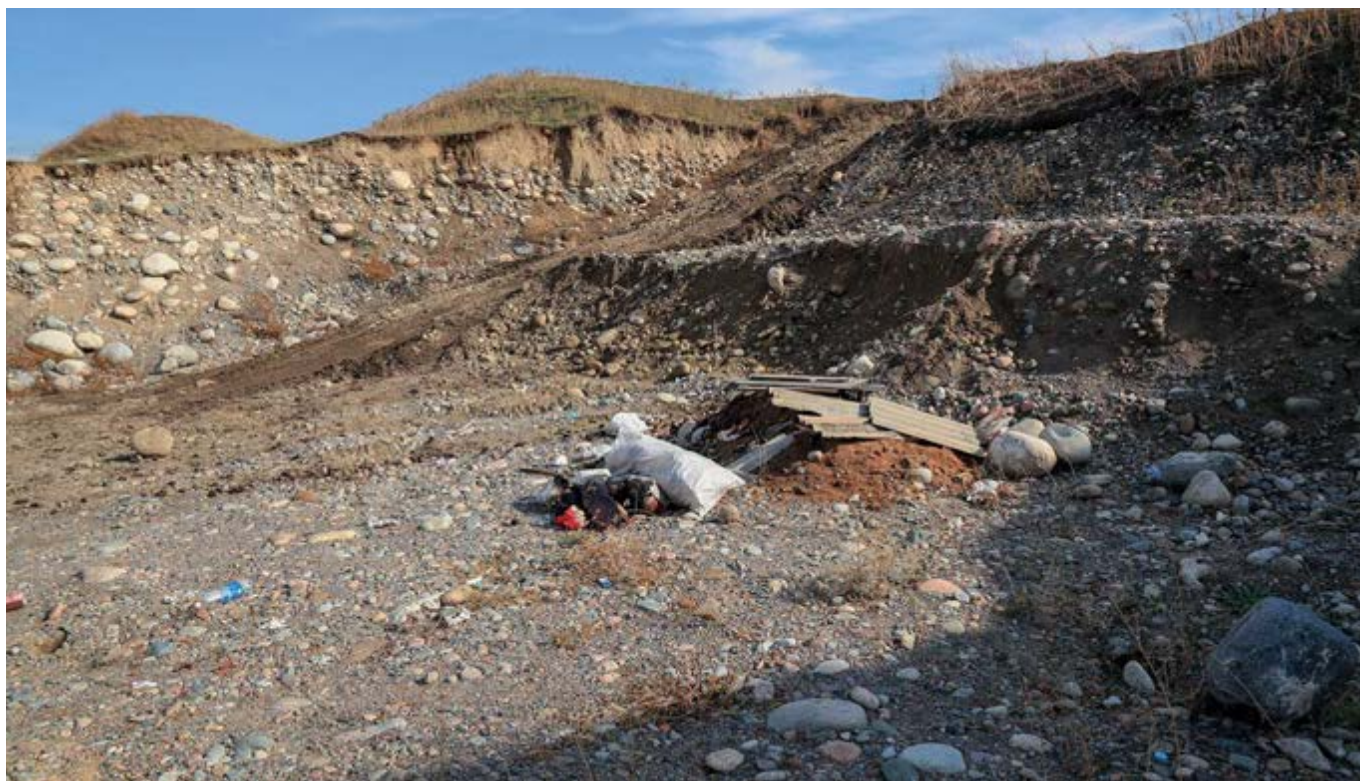
*Picture 46. **Pile of garbage at the downhill pass to the bridge.**
October 30, 2018.*

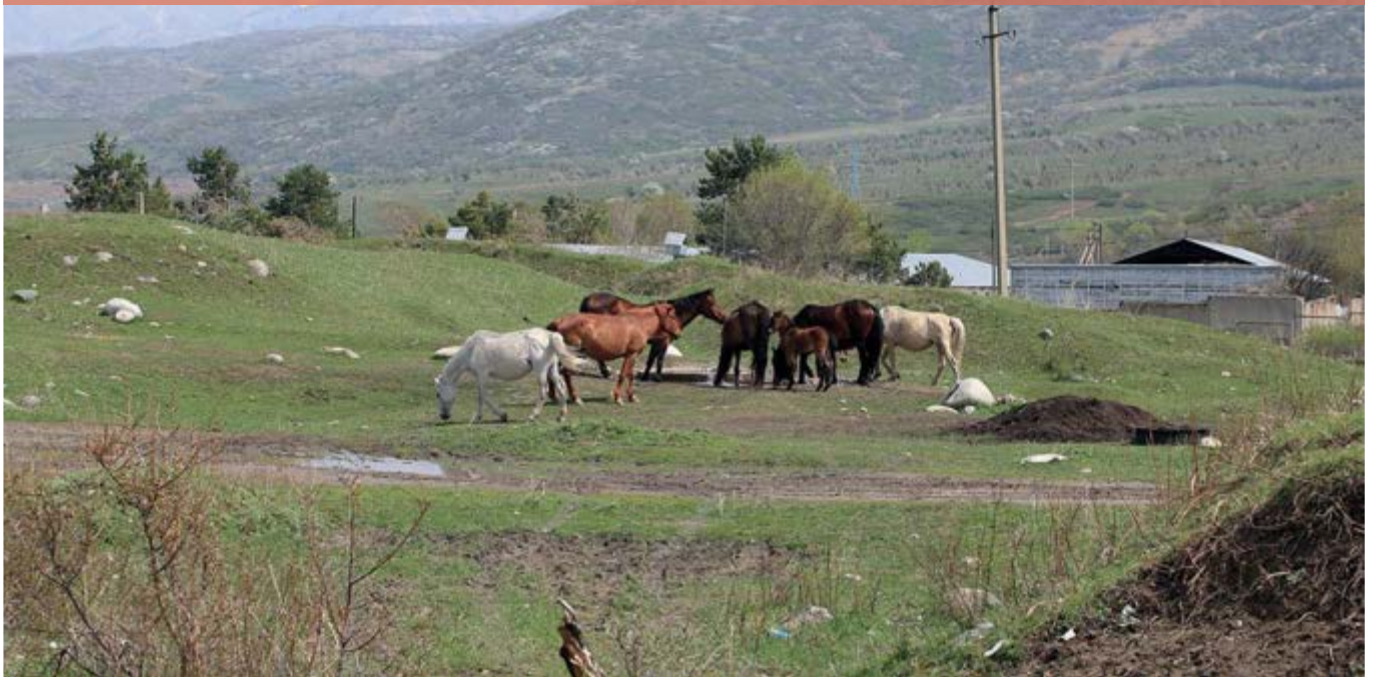
Picture 47. Livestock drinking bowl is set up by the water well.
April 17, 2018.

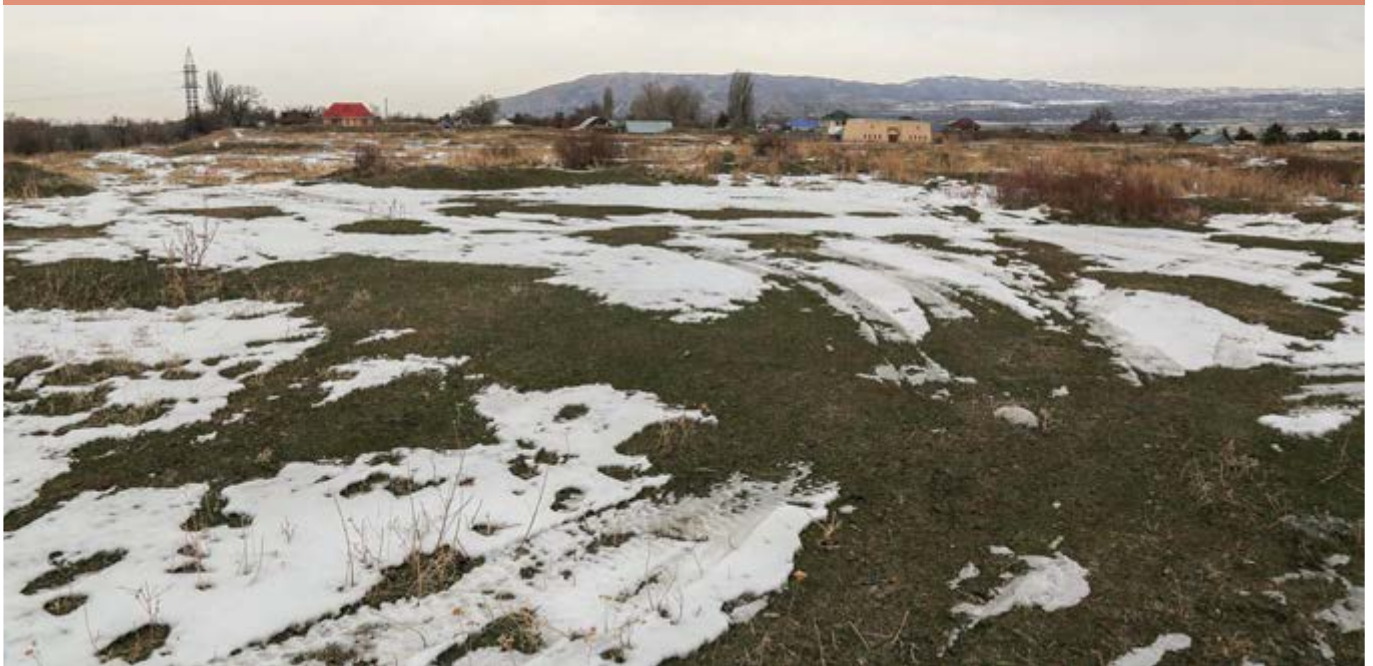
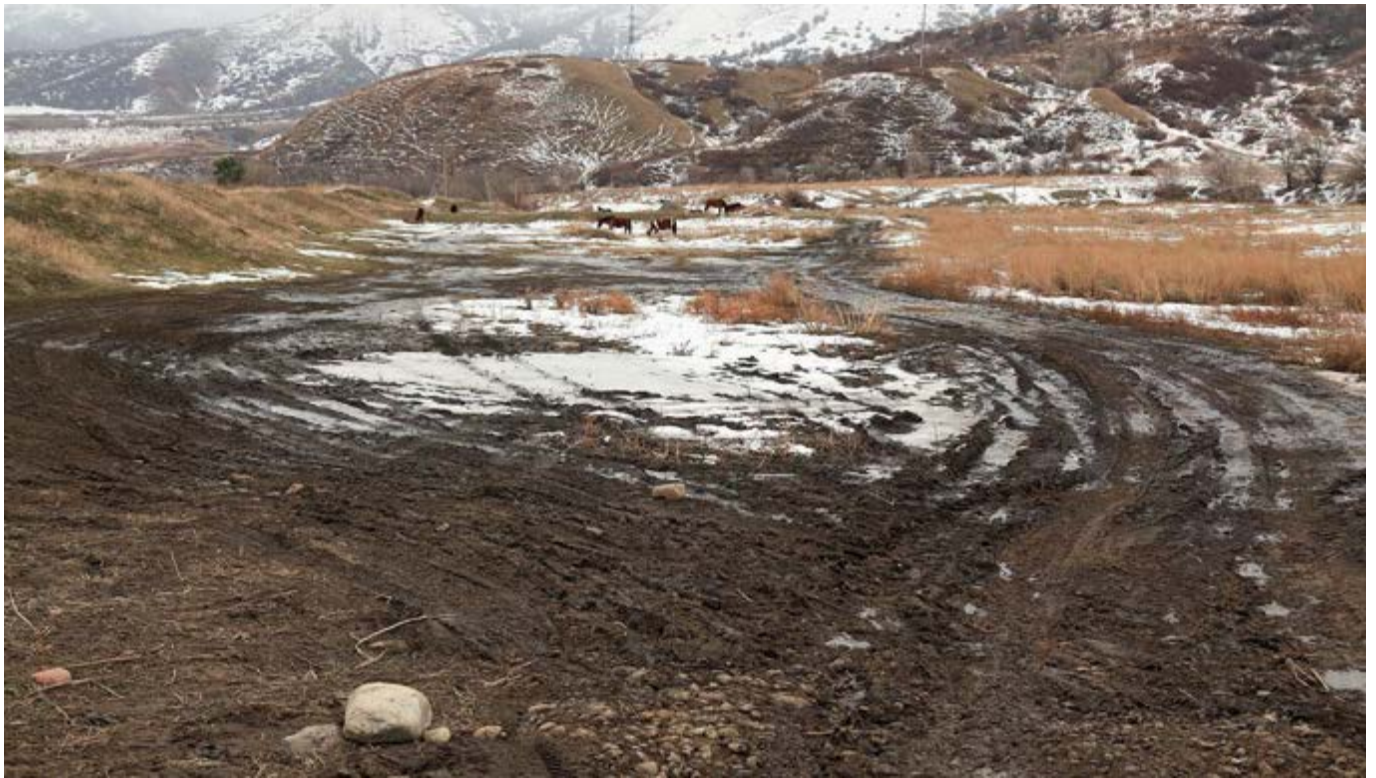
Compare to 2017, the visual attractiveness became worse due to the fact that off-roaders practically turned the south part of the hillfort into an entertainment arena. The local authorities are either unable to stop these illegal activities, or they turn a blind eye on it.

Picture 48. Off-road drivers practically turned the south part of the hillfort into an arena for entertainment.
December 16, 2018.

Picture 49. Off-road drivers practically turned the south part of the hillfort into an arena for entertainment.

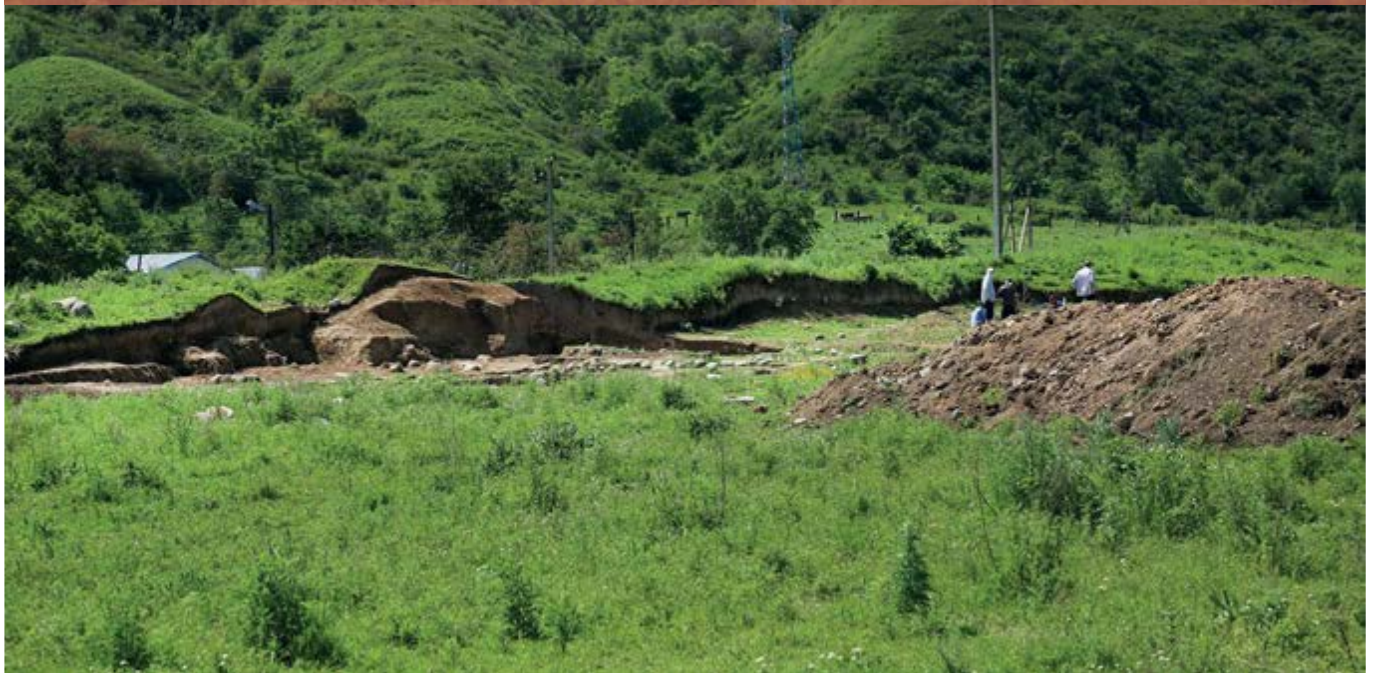
Picture 50. Excavated pit, the dirt is dumped onto the hillfort.

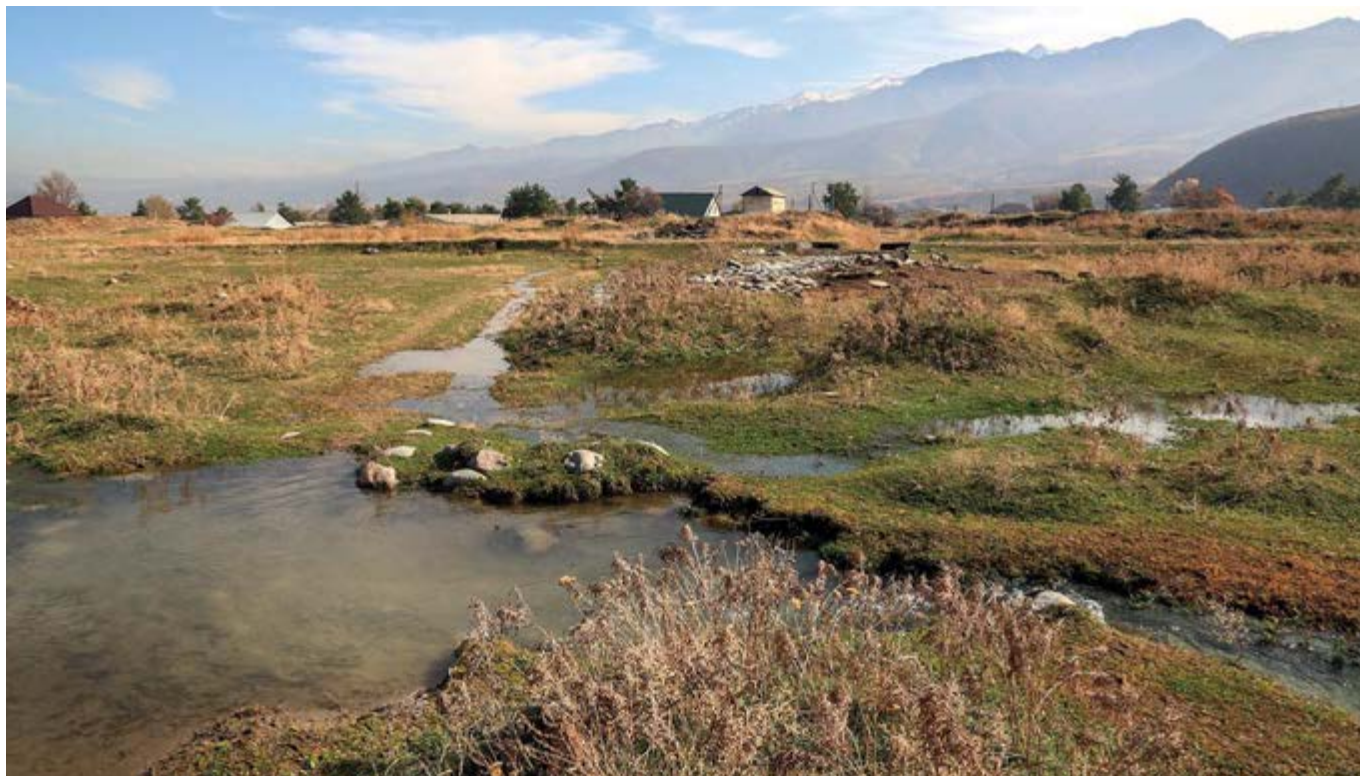
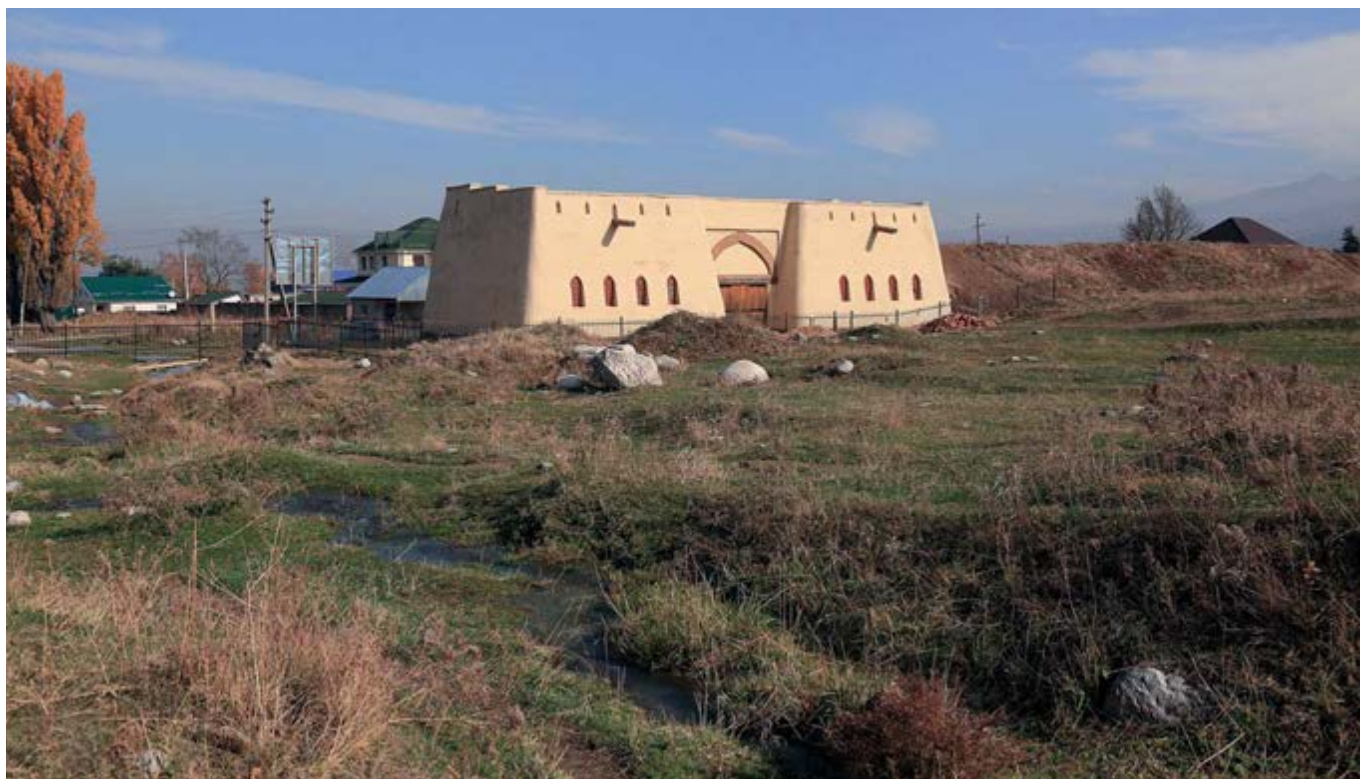
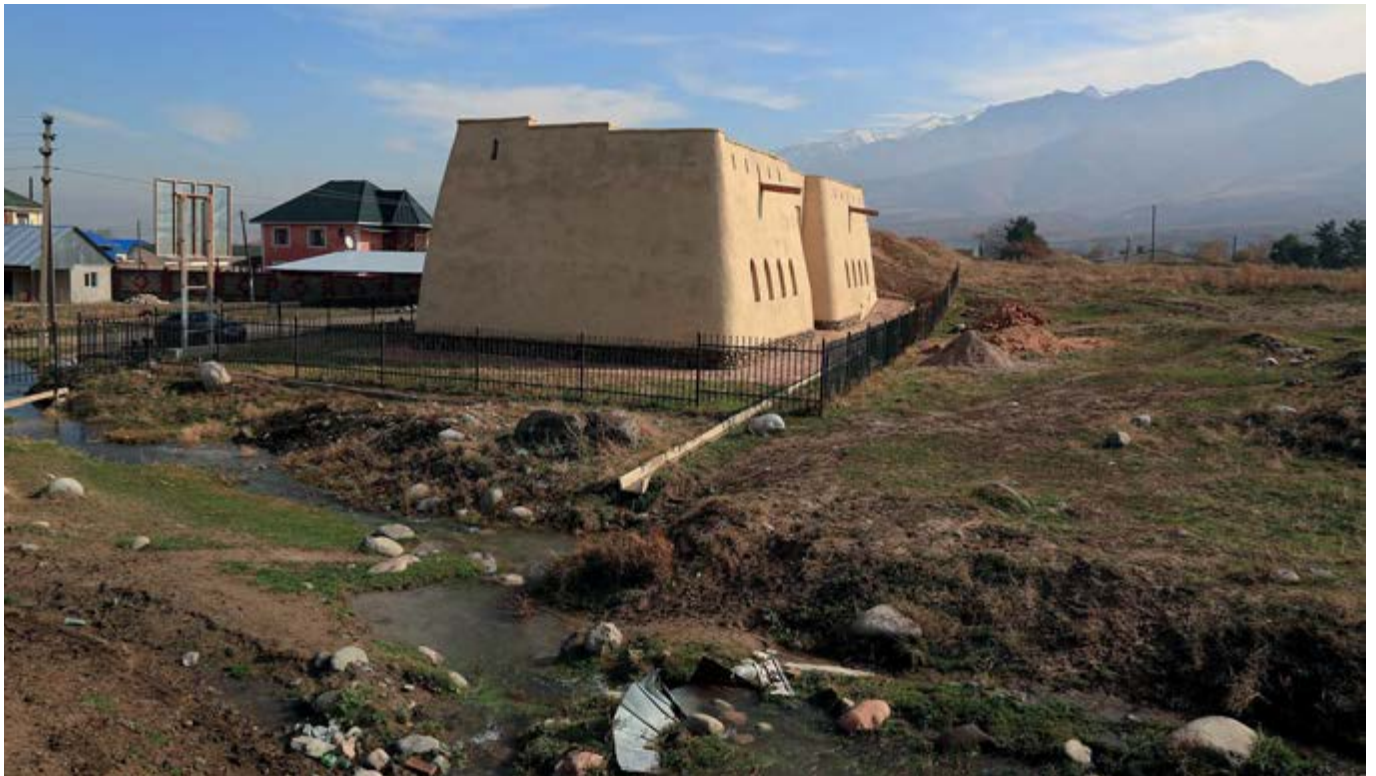
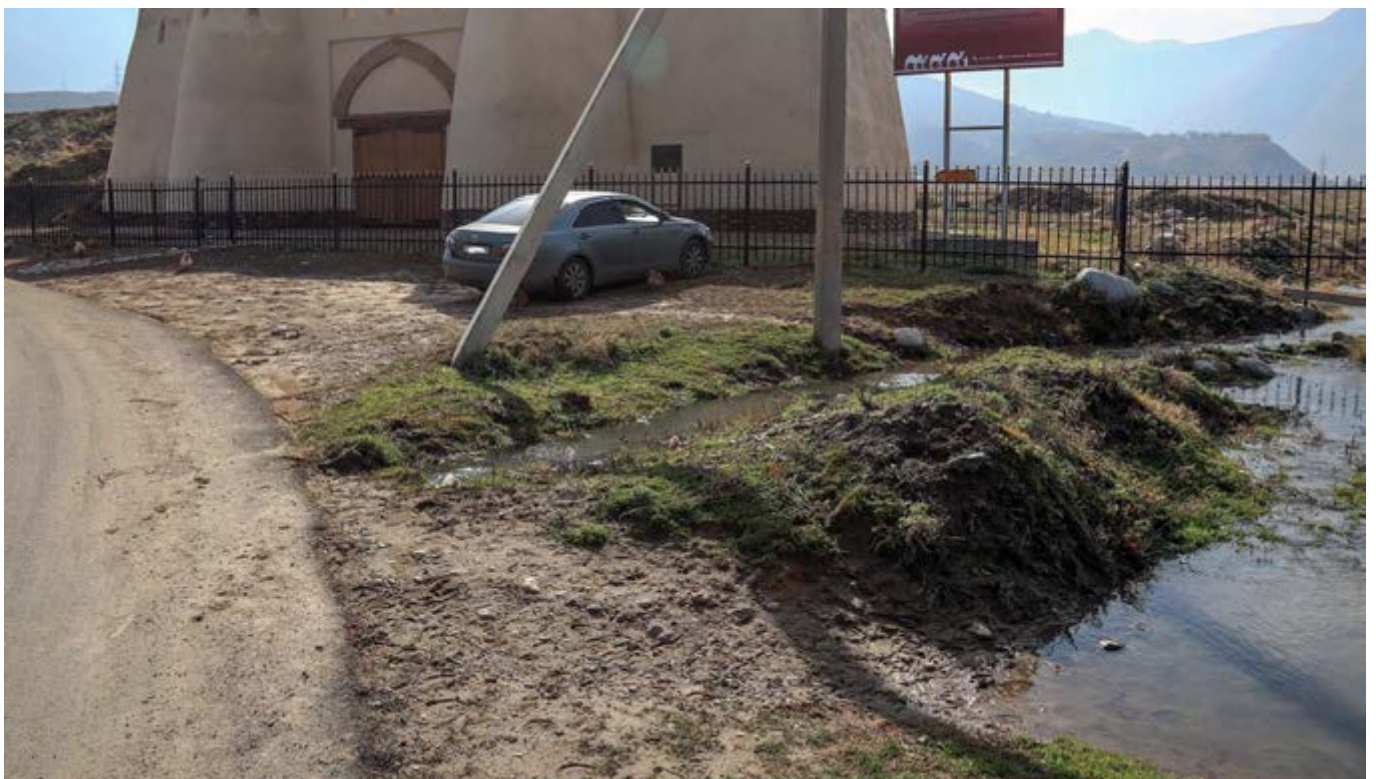
The integrity of the site is threatened by a significant increase in the volume of water flowing through the hillfort. It is possible that the volume has increased due to bursting of a water pipeline which passes through the territory of the monument, or increase in the water level in the stream flowing through the hillfort from south to north. Water erodes the soil, forms huge puddles in the northern part of the site and approaches the old excavations.

Picture 51. The water washes off the soil, creates huge puddles in the north part of the monument, and approaches the old excavations.
October 30, 2018.

Picture 52. The water washes off the soil, creates huge puddles in the north part of the monument.
October 30, 2018.

Picture 53. The water washes off the soil, creates huge puddles in the north part of the monument.

Picture 54. The water washes off the soil, creates huge puddles in the north part of the monument.

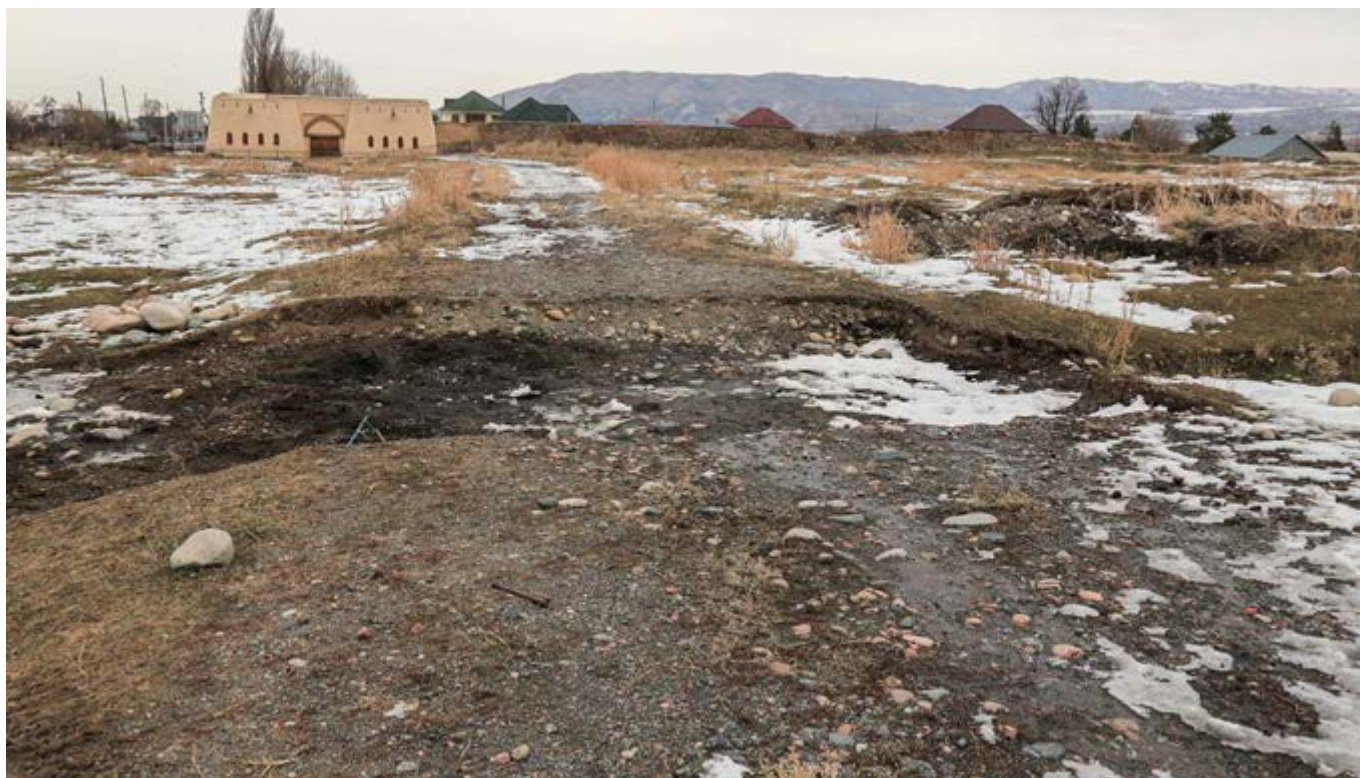
*Picture 55. **The ground is washed off in the central part of the hillfort.**
December 16, 2018.*

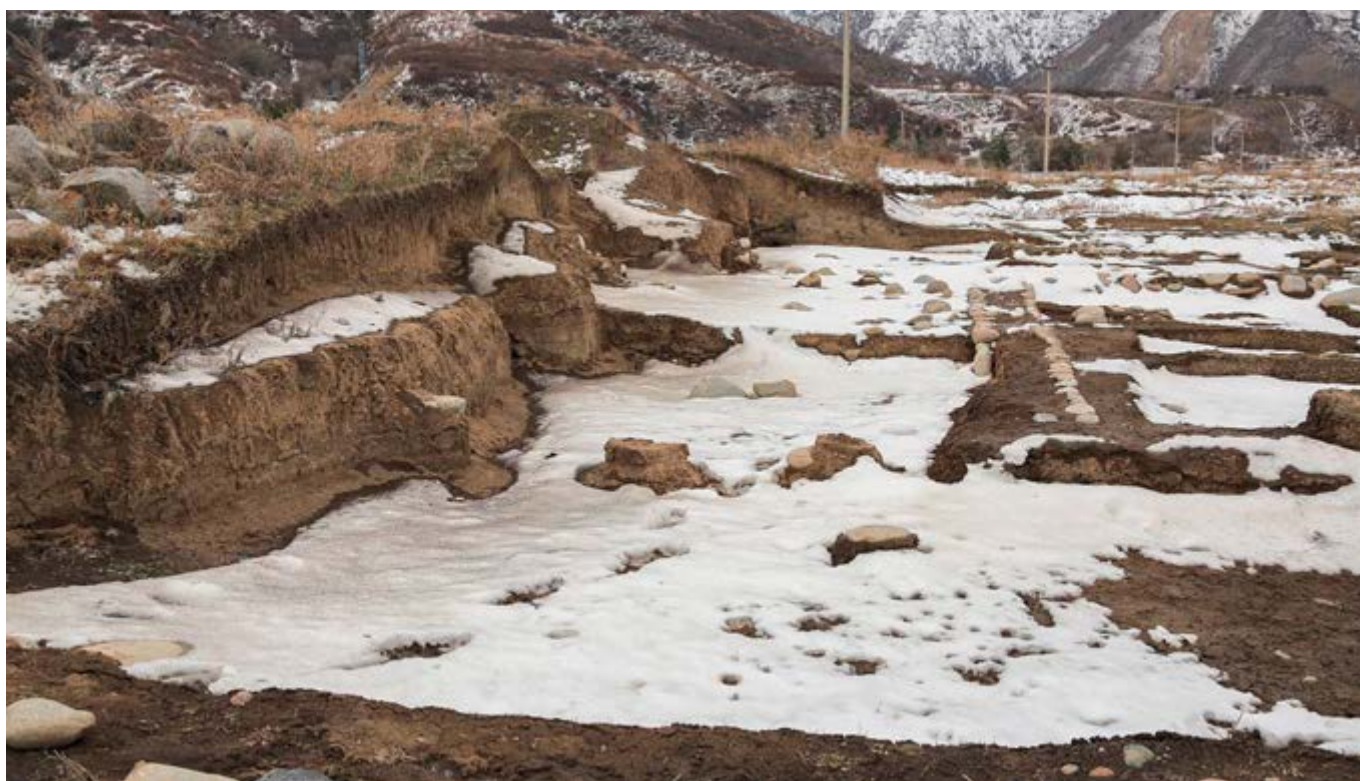
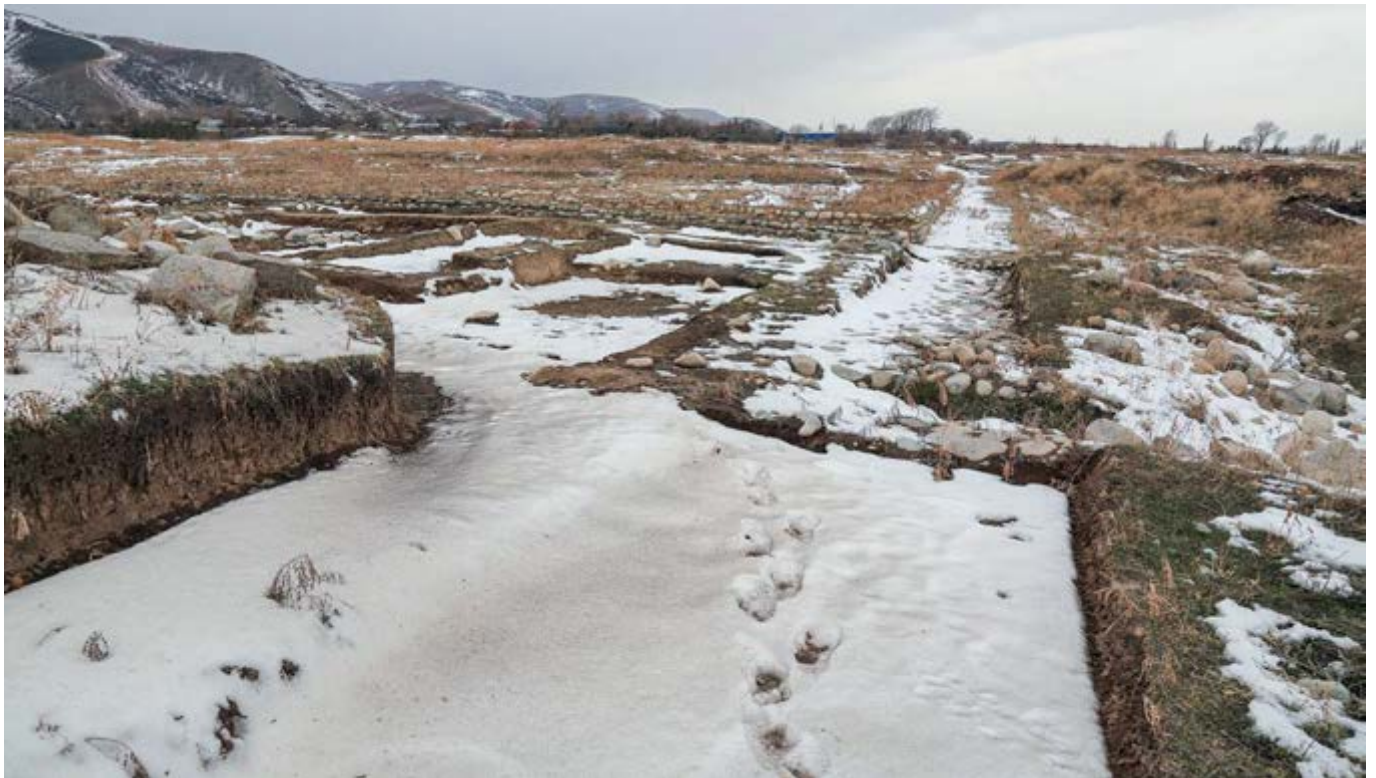
*Picture 56. **Condition of the excavation pits of 2018.**
December 16, 2018.*

*Picture 57. **Condition of the excavation pits of 2018.**
December 16, 2018.*
